CITROEN C4 Picasso: 1FSI377

Limited Technical Inspection

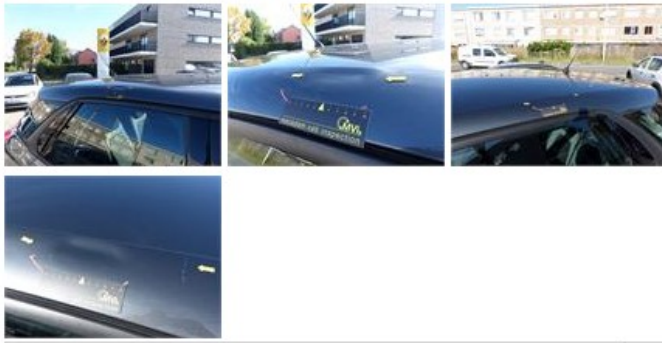
Total cost ex VAT	301,68
Door F R, Dent(s), Acceptable	0,00
<i>No pictures to display</i>	
Wing R R, Dent(s) and scratch(es), Acceptable	0,00
<i>No pictures to display</i>	
Seat cover F R, Stain, Acceptable	0,00
<i>No pictures to display</i>	
Door R L, Dent(s), Acceptable	0,00
<i>No pictures to display</i>	
Roof, Dent(s) and scratch(es), LI - Repair and paint (complete)	0,00
