BMW 5: 1G XK280			
Vinnnumber:	WBA5J31060D714840	Versionname:	5 TOURING 520dA 163PK Aut.
First Registrationdate:	27/05/2014	Fiscalpower:	
Expertise Mileage:	175309	Power Kw:	120
Bodytype:	Break	Body color:	Dark Brown
Gearbox:	Automatic	Paint type:	Metalic
Transmission:	Back	Rims summer:	Aluminium
Fueltype:	Diesel	Oil level:	OK
Battery functioning:	Yes	Parking lot:	3629
Number of doors:	5		
Number of seats:	5		
Number head rests:	5		
Rims summer:	Aluminium		
Category:	Passenger Car		
Oil level:	OK		
Registration Certificate Car (BE):	Yes

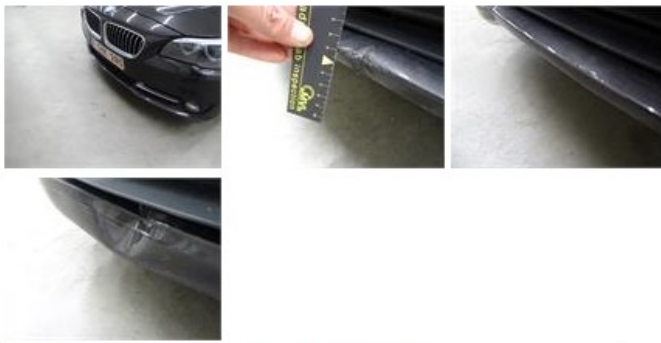
Alloy rim R L, Scratch(es), Acceptable		0,00
<i>No pictures to display</i>		
Bumper F, Dent(s) and scratch(es), LI - Repair and paint (complete)		254,16

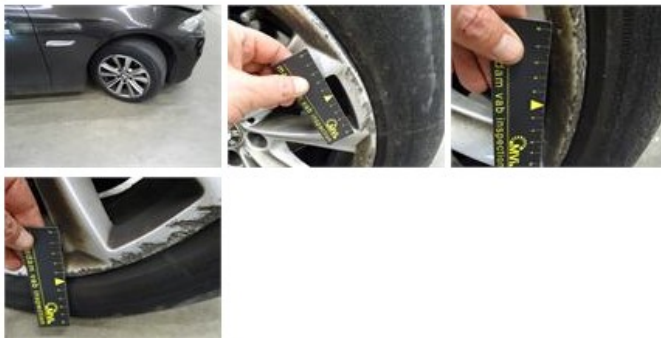
Alloy rim F R, Scratch(es), LI - Repair and paint (complete) 95,00
