RENAULT GRAND SCENIC: 1LAE827

Limited Technical Inspection

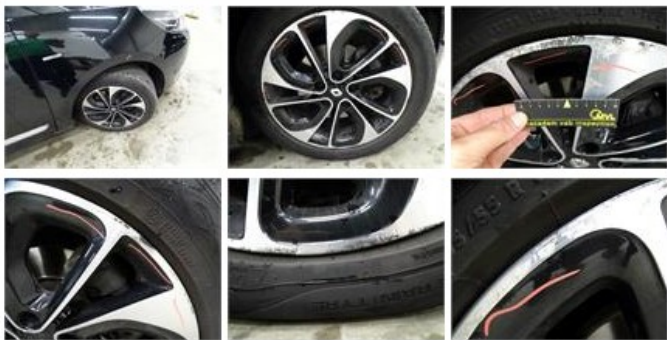
Emergency spare wheel	Yes
Total cost ex VAT	1767,03
Alloy rim F R polished, Scratch(es), LI - Repair and paint (complete)	95,00
