VOLKSWAGEN Touran: 1GG031			
Vinnnumber:	WVGZZZ1TZEW062371	Versionname:	TOURAN Trendline BMT Start/Stop 105PK
First Registrationdate:	3/02/2014	Fiscalpower:	
Expertise Mileage:	87949	Power Kw:	77
Bodytype:	Hatchback	Body color:	Dark Grey
Gearbox:	MAN 5 VIT	Paint type:	Metalic
Transmission:	Front	Rims summer:	Aluminium
Fueltype:	Diesel	Oil level:	OK
Battery functioning:	Yes	Parking lot:	3727
Number of doors:	5		
Number of seats:	5		
Number head rests:	5		
Rims summer:	Aluminium		
Category:	Passenger Car		
Oil level:	OK		
Registration Certificate Car (BE):	Yes

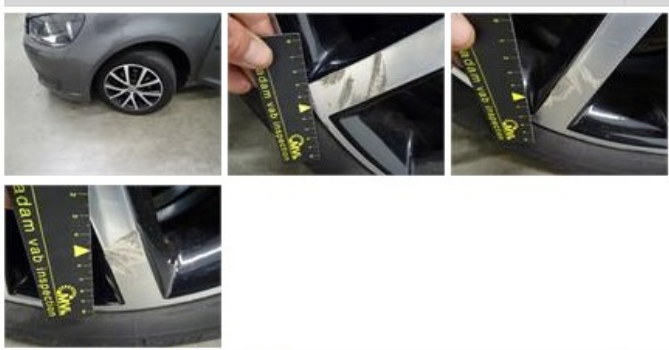
Assistance equipment			
Repair kit	Yes	Compressor	Yes
Total cost ex VAT			314,00
Alloy rim F L polished, Scratch(es), LI - Repair and paint (complete)			95,00
