**AUDI A3: 1FPQ763**

**Limited Technical Inspection**

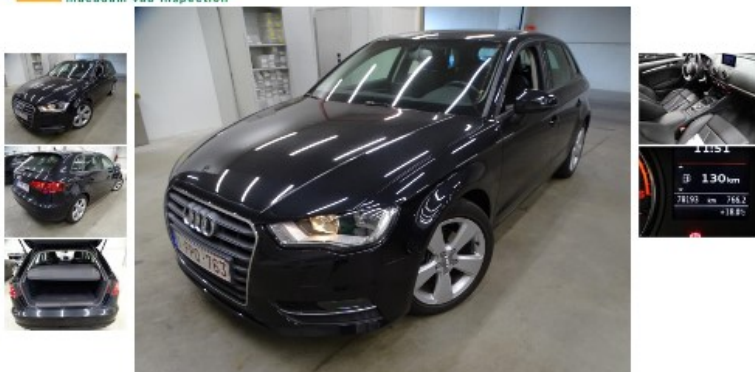
Vinnnumber:	<b>WAUZZZ8V6EA053155</b>	Versionname:	<b>A3 SB Ambition 105PK</b>
First Registrationdate:	<b>17/09/2013</b>	Fiscalpower:	
Expertise Mileage:	<b>78193</b>	Power Kw:	<b>77</b>
Bodytype:	<b>Hatchback</b>	Body color	<b>Black</b>
Gearbox:	<b>MAN 5 VIT</b>	Paint type	<b>Metalic</b>
Transmission:		Rims summer	<b>Aluminium</b>
Fueltype:	<b>Diesel</b>	Oil level	<b>OK</b>
Battery functioning	<b>Yes</b>	Parking lot	<b>4708</b>
Number of doors	<b>5</b>		
Number of seats	<b>5</b>		
Number head rests	<b>5</b>		
Rims summer	<b>Aluminium</b>		
Category	<b>Passenger Car</b>		
Oil level	<b>OK</b>		
Registration Certificate Car (BE)	<b>Yes</b>
