## VOLKSWAGEN Golf: 1G6N991

## Limited Technical Inspection

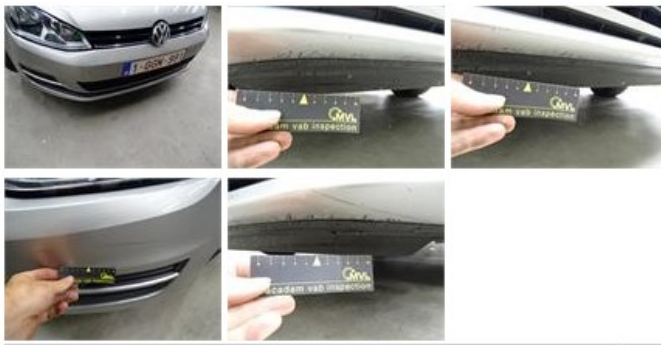
Total cost ex VAT	<b>211,80</b>
Wing F L, Scratch(es), Acceptable	<b>0,00</b>
<i>No pictures to display</i>	
Bumper R, Scratch(es), Acceptable	<b>0,00</b>
<i>No pictures to display</i>	
Wheel cover F R, Scratch(es), Acceptable	<b>0,00</b>
<i>No pictures to display</i>	
Bumper F, Scratch(es), LI - Repair and paint (complete)	<b>211,80</b>
