**FORD Fiesta: SM8213**

**Limited Technical Inspection**

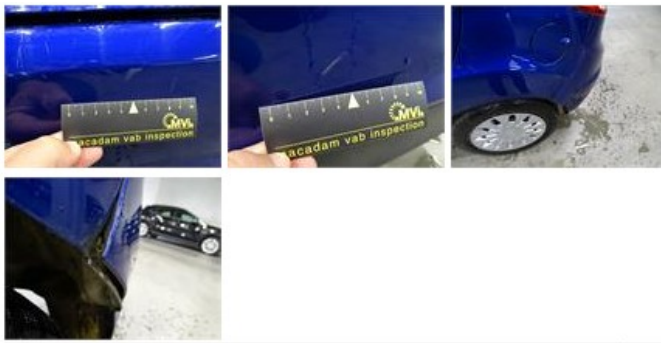
Total cost ex VAT	1624,66
Wheel cover F R, Scratch(es), Acceptable	0,00
<i>No pictures to display</i>	
Interior, Dirty, Acceptable	0,00
<i>No pictures to display</i>	
Bumper R, Scratch(es), LI - Repair and paint (complete)	169,44

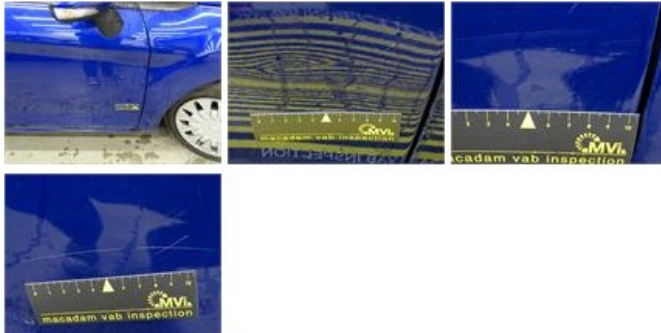
Door F L, Scratch(es), Acceptable	0,00
<i>No pictures to display</i>	
Door F R, Dent(s) and scratch(es), LI - Repair and paint (complete)	302,68

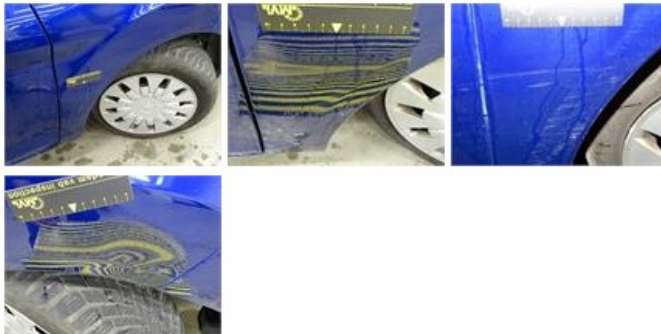
Wing F R, Dent(s) and scratch(es), LI - Repair and paint (complete)	296,14
---	--------

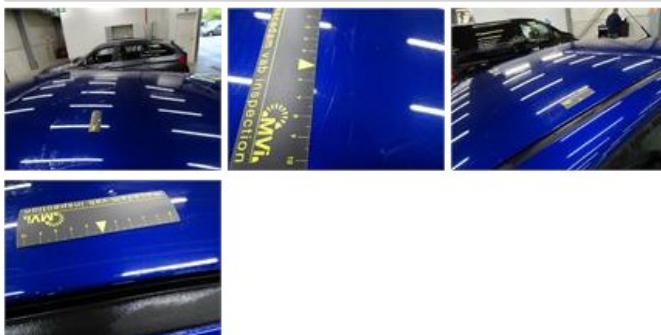
Door R R, Scratch(es), Acceptable	0,00
<i>No pictures to display</i>	
Wing R R, Dent(s) and scratch(es), Acceptable	0,00
<i>No pictures to display</i>	
Trunk lid covering R, Scratch(es), Acceptable	0,00
<i>No pictures to display</i>	
Door R L, Dent(s) and scratch(es), Acceptable	0,00
<i>No pictures to display</i>	
Roof, Scratch(es), LI - Repair and paint (complete)	385,20
