LU Mercedes GLA 200: GZ4675

Limited Technical Inspection

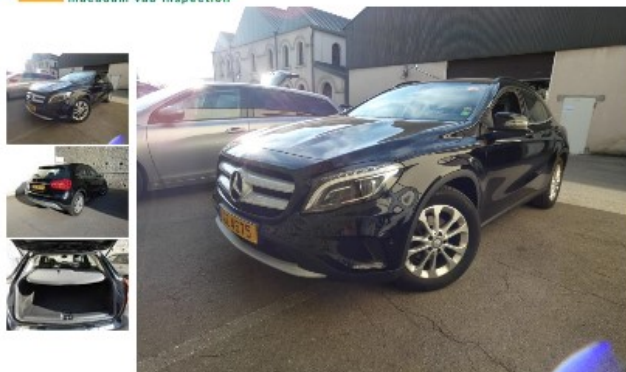
Vinnumber:	WDC1569081J300784	Versionname:	d Style
First Registrationdate:	4/10/2016	Fiscalpower:	
Expertise Mileage:	54256	Power Kw:	100
Bodytype:		Body color:	Black
Gearbox:	MAN 6 VIT	Paint type:	Metalic
Transmission:	Front	Rims summer:	Aluminium
Fueltype:	Diesel	Oil level:	OK
Maintenance:	A1 DANS 329 JOURS	Parking lot:	1324
Maintenance:	OK		
Battery functioning:	Yes		
Number of doors:	5		
Number of seats:	5		
Number head rests:	5		
Rims summer:	Aluminium		
Category:	Passenger Car		
Oil level:	OK		
Registration Certificate Car (BE):	No
