SKODA Octavia: 1FQQ741

Limited Technical Inspection

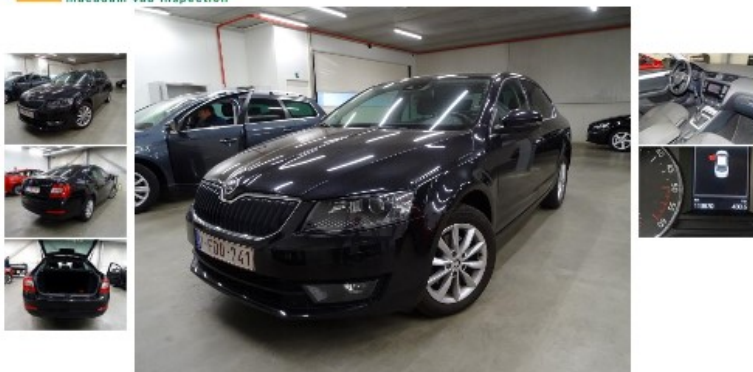
Vinnumber:	TMBAG7NE0E0061191	Versionname:	OCTAVIA BER Ambition
First Registrationdate:	25/09/2013	Fiscalpower:	105PK
Expertise Mileage:	113870	Power Kw:	77
Bodytype:		Body color	Black
Gearbox:	MAN 5 VIT	Paint type	Metalic
Transmission:	Front	Rims summer	Aluminium
Fueltype:	Diesel	Oil level	OK
Maintenance	NOT OK	Parking lot	1313
Battery functioning	Yes		
Number of doors	5		
Number of seats	5		
Number head rests	5		
Rims summer	Aluminium		
Category	Passenger Car		
Oil level	OK		
Registration Certificate Car (BE)	Yes

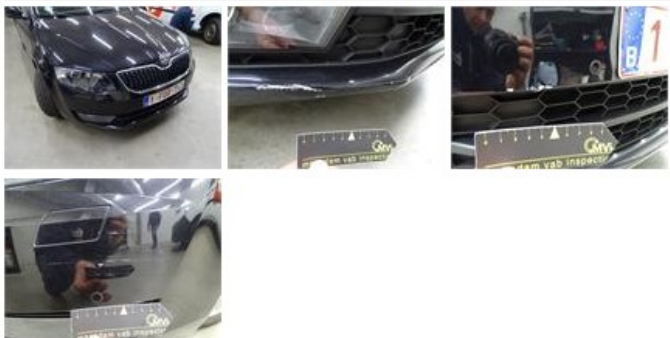
Maintenance, Maintenance, Execute	0,00
<i>No pictures to display</i>	
Tailgate, Scratch(es), Acceptable	0,00
<i>No pictures to display</i>	
Bumper F, Scratch(es), LI - Repair and paint (complete)	211,80
