## VOLVO XC60: 1HTJ068

## Limited Technical Inspection

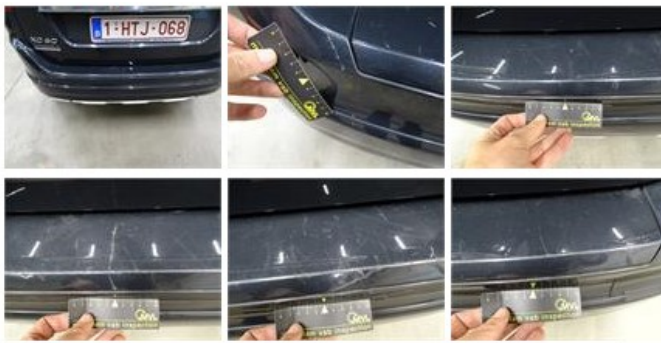
Total cost ex VAT	<b>464,72</b>
Door R L, Dent(s), Acceptable	<b>0,00</b>
<i>No pictures to display</i>	
Door F L, Dent(s), Acceptable	<b>0,00</b>
<i>No pictures to display</i>	
Wing R R, Scratch(es), Acceptable	<b>0,00</b>
<i>No pictures to display</i>	
Wing R L, Dent(s), Acceptable	<b>0,00</b>
<i>No pictures to display</i>	
Bumper R, Scratch(es), LI - Repair and paint (complete)	<b>254,16</b>
