**TOYOTA AURIS TOURING SPORTS: 1PJY212**

**Limited Technical Inspection**

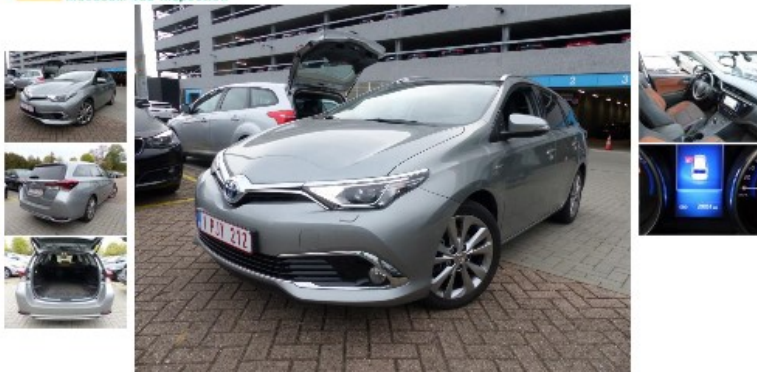
Vinnumber:	<b>SB1ZS3JE10E265630</b>	Versionname:	<b>1.8 HYBRID LOUNGE CVT</b>
First Registrationdate:	<b>19/07/2016</b>	Fiscalpower:	<b>AUTO</b>
Expertise Mileage:	<b>29951</b>	Power Kw:	<b>100</b>
Bodytype:		Body color:	<b>Grey</b>
Gearbox:	<b>Automatic</b>	Paint type:	<b>Metalic</b>
Transmission:	<b>Front</b>	Rims summer:	<b>Aluminium</b>
Fueltype:	<b>Hybrid Petrol</b>	Oil level:	<b>OK</b>
Battery functioning:	<b>Yes</b>	Parking lot:	<b>4730</b>
Number of doors:	<b>5</b>		
Number of seats:	<b>5</b>		
Number head rests:	<b>5</b>		
Rims summer:	<b>Aluminium</b>		
Category:	<b>Passenger Car</b>		
Oil level:	<b>OK</b>		
Registration Certificate Car (BE):	<b>Yes</b>
