FORD S Max: 1EYW496

Limited Technical Inspection

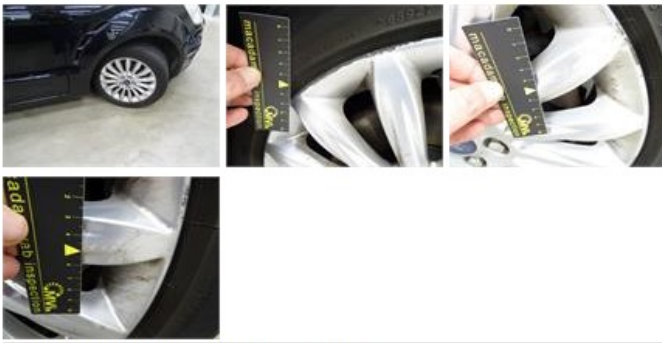
Total cost ex VAT	422,21
Door R R, Dent(s) and scratch(es), Acceptable	0,00
<i>No pictures to display</i>	
Bonnet, Scratch(es), Acceptable	0,00
<i>No pictures to display</i>	
Door R L, Scratch(es), Acceptable	0,00
<i>No pictures to display</i>	
Alloy rim F R, Scratch(es), LI - Repair and paint (complete)	95,00
