**MERCEDES C: 1GFU421**

**Limited Technical Inspection**

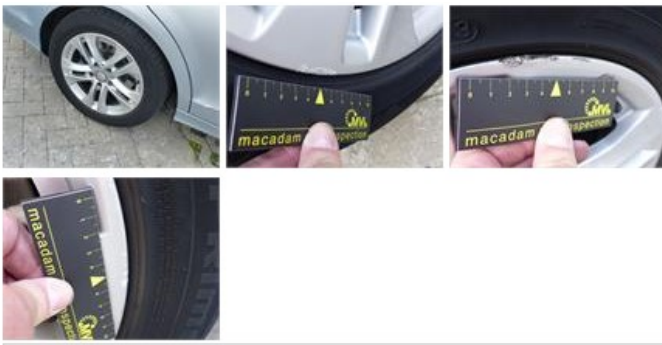
Total cost ex VAT	933,43
Door R L, Dent(s), Acceptable	0,00
<i>No pictures to display</i>	
Alloy rim R R, Scratch(es), LI - Repair and paint (complete)	95,00

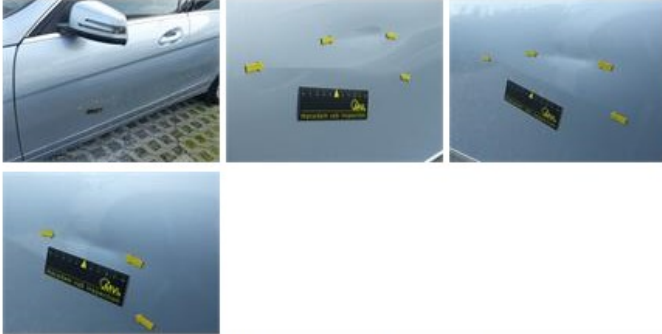
Door F L, Dent(s), LI - Repair and paint (complete) 390,35
