LU Mercedes gla: GZ4706

Limited Technical Inspection

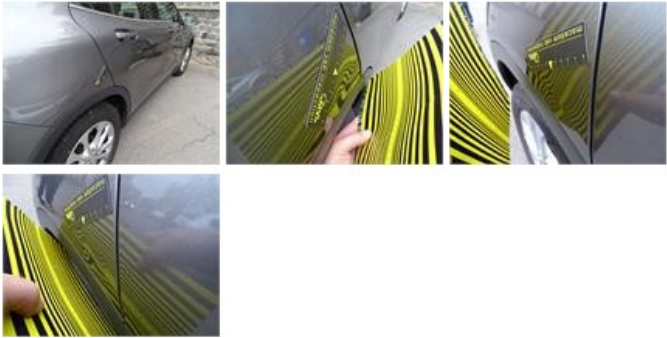
Roof pillar L, Dent(s), Acceptable	0,00
<i>No pictures to display</i>	
Bumper F, Stone chip(s), Acceptable	0,00
<i>No pictures to display</i>	
Wing R R, Dent(s), LI - Repair and paint (complete)	441,84
