RENAULT Grand Scenic: 1FVL818

Limited Technical Inspection

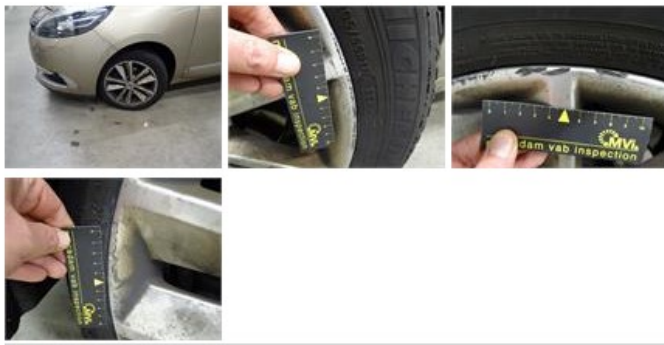
Emergency spare wheel	Yes	Jack	Yes
Total cost ex VAT			1044,80
Alloy rim R L, Scratch(es), Acceptable			0,00
<i>No pictures to display</i>			
Alloy rim F L, Scratch(es), LI - Repair and paint (complete)			95,00
