RENAULT MEGANE GRANDTOUR: 1LGH650

Limited Technical Inspection

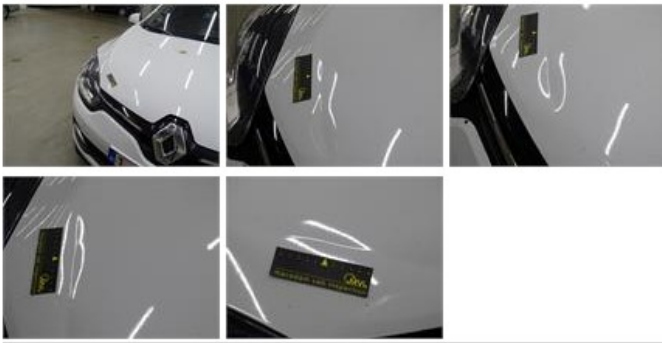
Total cost ex VAT	771,58
Bumper R, Scratch(es), Acceptable	0,00
<i>No pictures to display</i>	
Bumper F, Stone chip(s), Acceptable	0,00
<i>No pictures to display</i>	
Bonnet, Dent(s), LI - Repair and paint (complete)	290,08

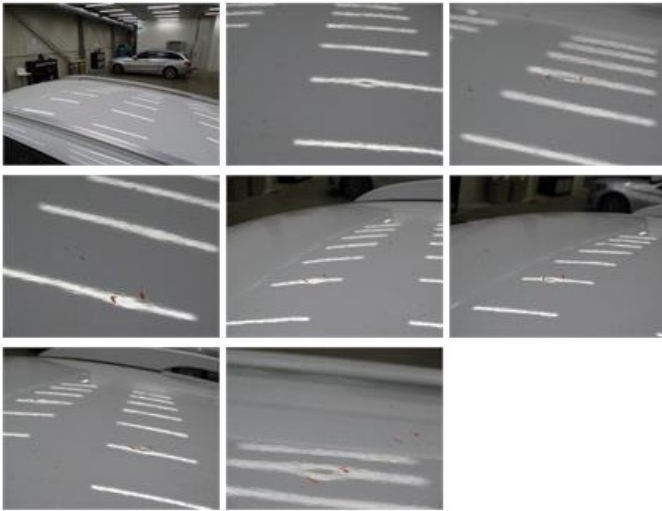
Door R L, Scratch(es), Acceptable	0,00
<i>No pictures to display</i>	
Tailgate, Dent(s) and scratch(es), Acceptable	0,00
<i>No pictures to display</i>	
Bodywork, Not original part, Acceptable	0,00
<i>No pictures to display</i>	
Roof, Hail damage, LI - Repair and paint (complete)	481,50
