PEUGEOT 308: 1HZC924

Limited Technical Inspection

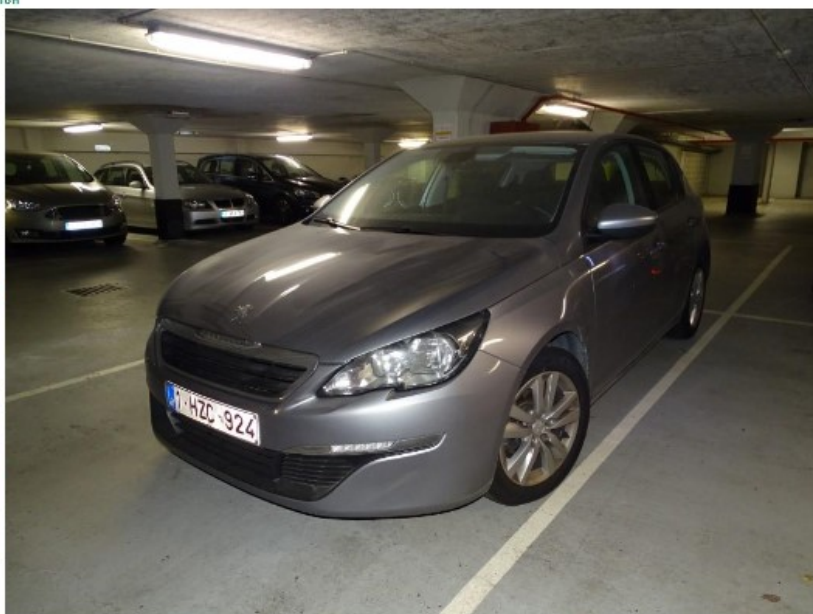
Vinnumber:	VF3LB9HPAES189818	Versionname:	1.6 HDI 68KW ACTIVE
First Registrationdate:	4/11/2014	Fiscalpower:	
Expertise Mileage:	20345	Power Kw:	68
Bodytype:		Body color:	Grey
Gearbox:	MAN 5 VIT	Paint type:	Metalic
Transmission:	Front	Rims summer:	Aluminium
Fueltype:	Diesel	Oil level:	OK
Maintenance:	OK	Parking lot:	3824
Battery functioning:	Yes		
Number of doors:	5		
Number of seats:	5		
Number head rests:	5		
Rims summer:	Aluminium		
Category:	Passenger Car		
Oil level:	OK		
Registration Certificate Car (BE):	Yes

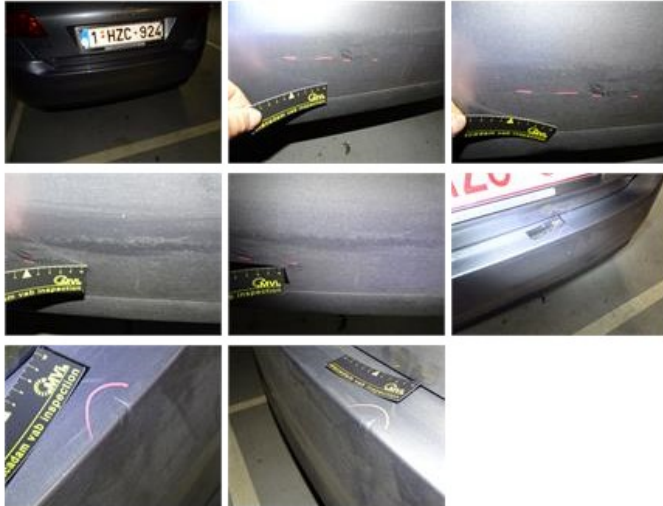
Bumper F, Dent(s), Acceptable	0,00
<i>No pictures to display</i>	
Alloy rim R R, Scratch(es), Acceptable	0,00
<i>No pictures to display</i>	
Bumper R, Dent(s) and scratch(es), LI - Repair and paint (complete)	259,80
