AUDI A3: 1HSR520

Limited Technical Inspection

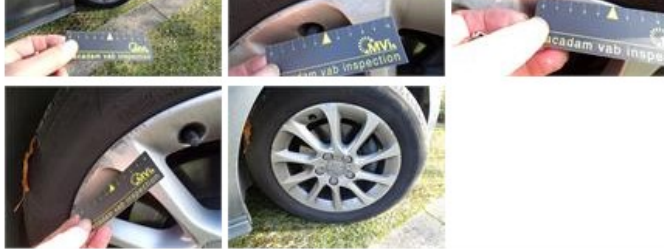
Alloy rim F R, Scratch(es), LI - Repair and paint (complete)	95,00
--------------------------------------------------------------	-------
