BMW 3 TOURING: 1KTK180

Limited Technical Inspection

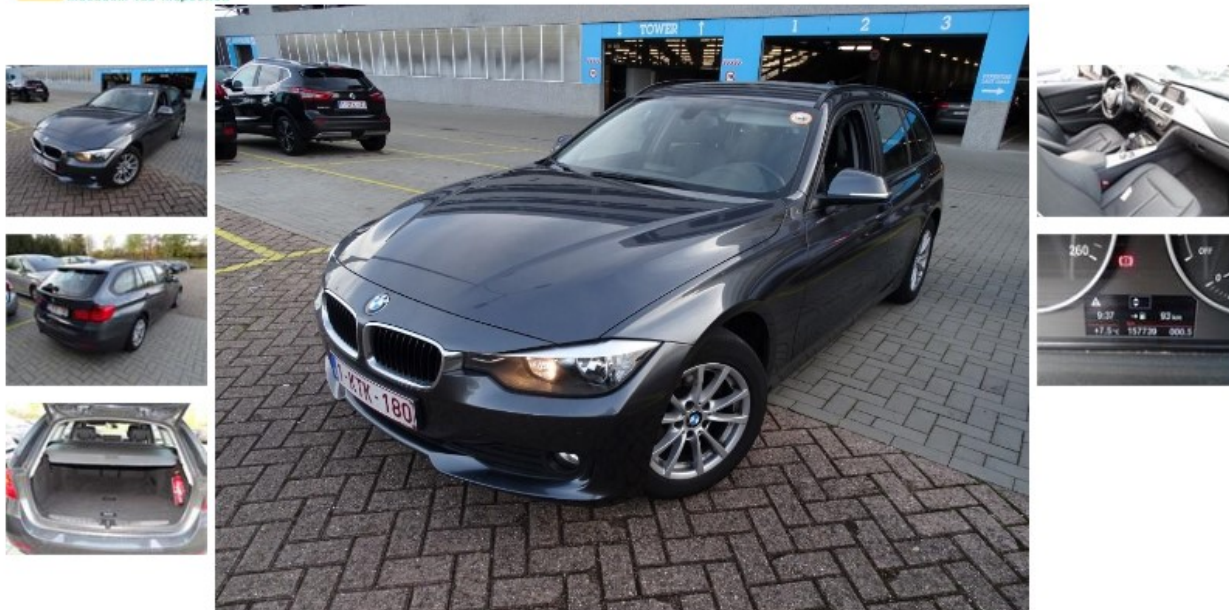
Vinnumber:	WBA3K11040F840398	Versionname:	2.0 318D (100KW) TOURING
First Registrationdate:	30/06/2015	Fiscalpower:	
Expertise Mileage:	157739	Power Kw:	100
Bodytype:	Break	Body color:	Grey
Gearbox:	MAN 6 VIT	Paint type:	Metalic
Transmission:	Back	Rims summer:	Aluminium
Fueltype:	Diesel	Oil level:	OK
Maintenance:	OK	Parking lot:	2827
Battery functioning:	Yes		
Number of doors:	5		
Number of seats:	5		
Number head rests:	5		
Rims summer:	Aluminium		
Category:	Passenger Car		
Oil level:	OK		
Registration Certificate Car (BE):	Yes

Airco functioning	OK	Battery functioning	Yes
Tires wear profile	NOT OK	Power steering	Yes
Idle position	OK	Sound engine	OK
Engine startingtime	OK	Clutch test	OK
Exhaust gass	OK	Wiper fluid level	OK
Handbrake	OK	Transmission	OK
		Lighting	OK
		Wiperblades	OK

205/60/16/92 W LightMetal				
Summer tyres:	Fr.L.	Bridgestone: 2 mm	Fr.R.	Bridgestone: 2 mm
	Re.L.	Michelin: 4 mm	Re.R.	Michelin: 4 mm
