FORD Grand C-Max: 1GXH11

Limited Technical Inspection

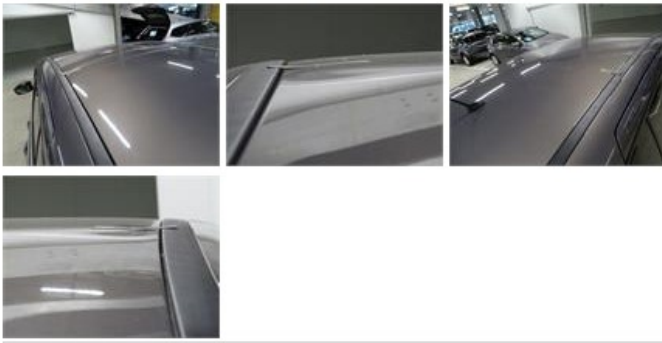
Total cost ex VAT	738,95
Wing F L, Dent(s), Acceptable	0,00
<i>No pictures to display</i>	
Roof, Dent(s), PDR - Paintless dent repair	82,80

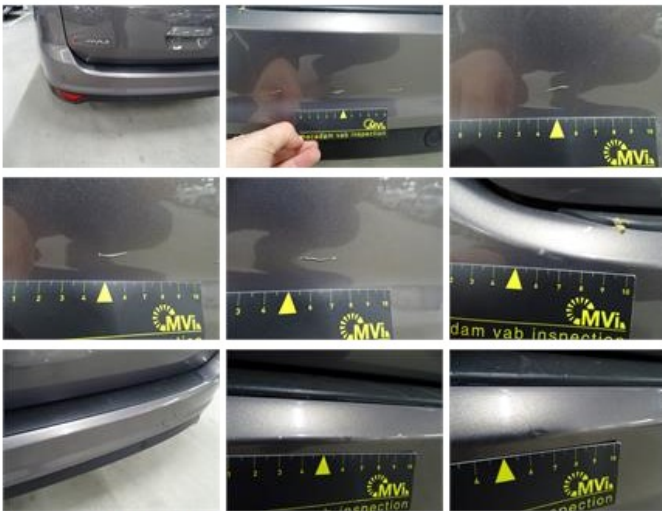
Bumper R, Scratch(es), LI - Repair and paint (complete)	211,80
---	--------
