BMW X3: WD8488

Limited Technical Inspection

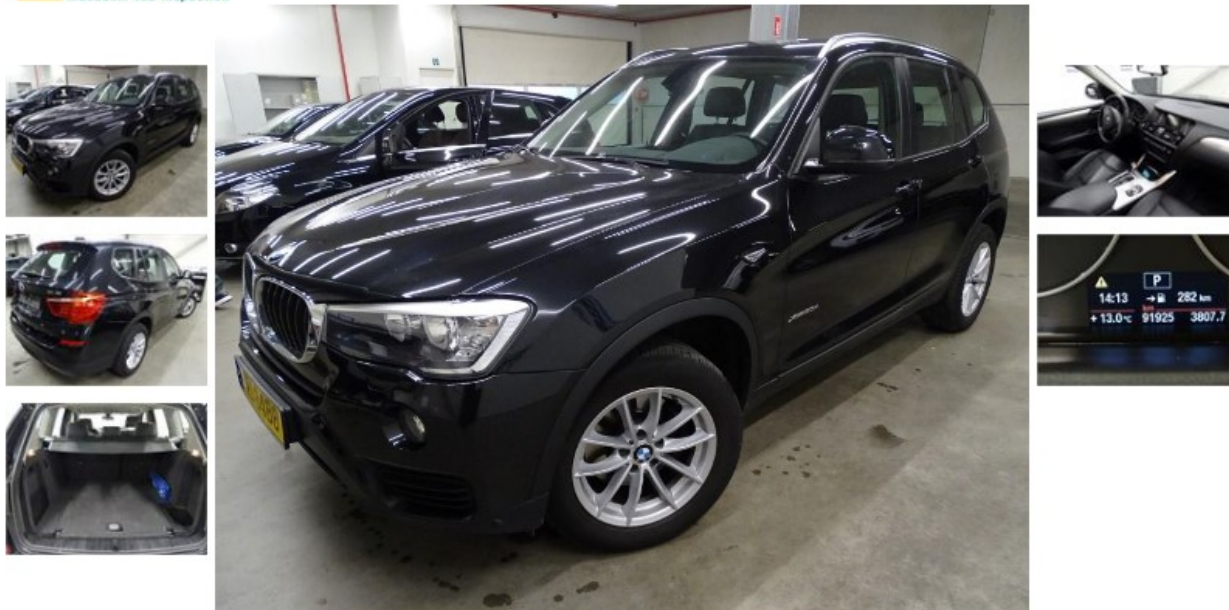
Vinnumber:	WBAWZ510700L01938	Versionname:	X3 2.0dA xDrive20 190PK Aut.
First Registrationdate:	12/08/2014	Fiscalpower:	
Expertise Mileage:	91925	Power Kw:	140
Bodytype:	SUV	Body color:	Black
Gearbox:	Automatic	Paint type:	Metallic
Transmission:	4 Weel	Rims summer:	Aluminium
Fueltype:	Diesel	Oil level:	OK
Battery functioning:	Yes	Parking lot:	2816
Number of doors:	5		
Number of seats:	5		
Number head rests:	5		
Rims summer:	Aluminium		
Category:	Passenger Car		
Oil level:	OK		
Registration Certificate Car (BE):	Yes

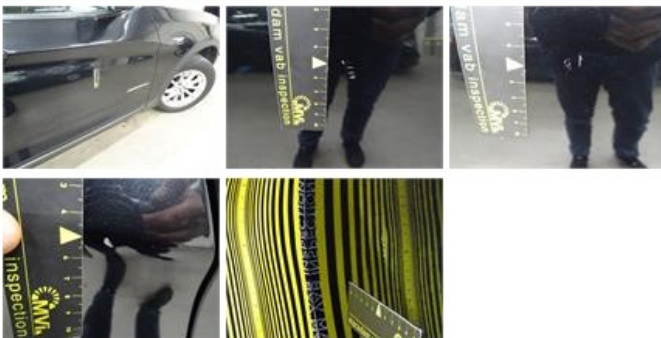
Door F R, Dent(s) and scratch(es), LI - Repair and paint (complete)

382,02
