VOLKSWAGEN Golf: 1HXA819

Limited Technical Inspection

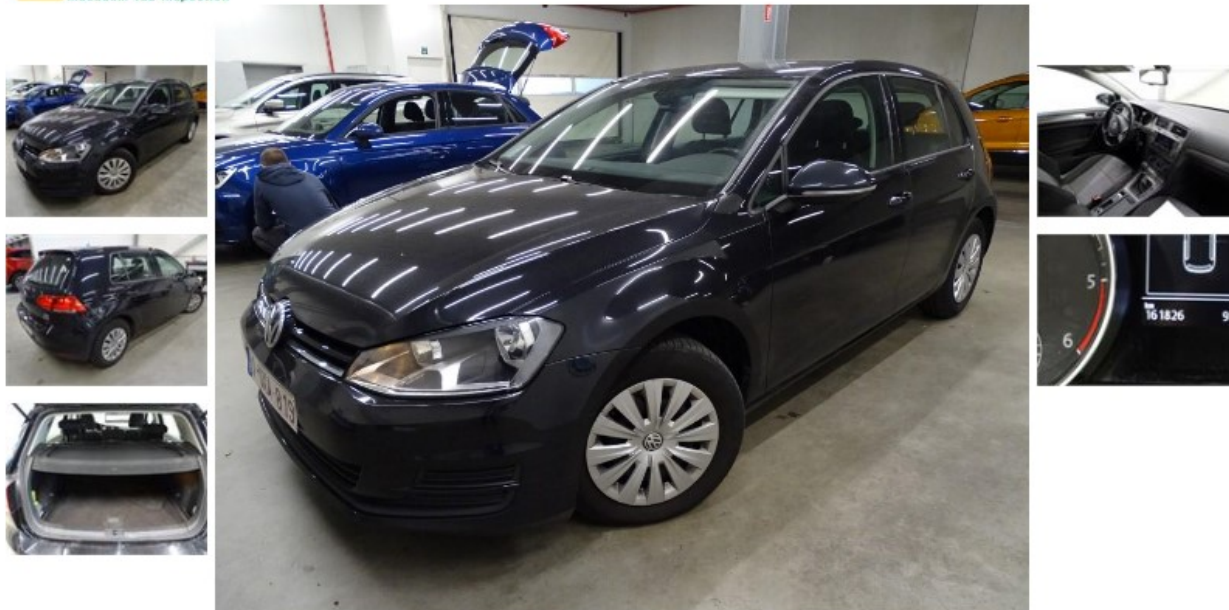
Vinnumber:	WVWZZZAUZEW398447	Versionname:	GOLF BER Trendline 90PK
First Registrationdate:	17/10/2014	Fiscalpower:	
Expertise Mileage:	161826	Power Kw:	66
Bodytype:	Hatchback	Body color:	Black
Gearbox:	MAN 5 VIT	Paint type:	Metalic
Transmission:	Front	Rims summer:	Steel
Fueltype:	Diesel	Oil level:	OK
Battery functioning:	Yes	Parking lot:	1105
Number of doors:	5		
Number of seats:	5		
Number head rests:	5		
Rims summer:	Steel		
Category:	Passenger Car		
Oil level:	OK		
Registration Certificate Car (BE):	Yes
