VOLVO S80: 1FGU411

Limited Technical Inspection

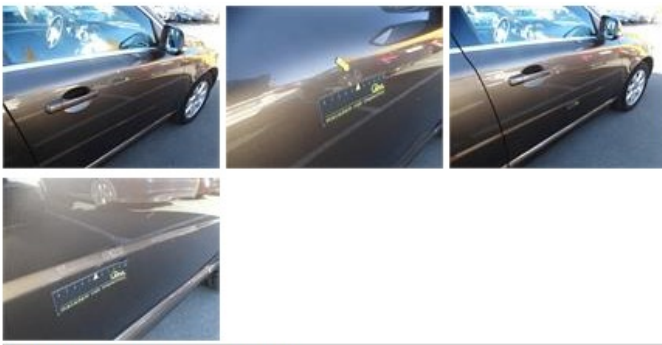
Repair kit	Yes	Compressor	Yes
Total cost ex VAT			629,58
Door F R, Dent(s) and scratch(es), LI - Repair and paint (complete)			382,02
