**MERCEDES C: 1DHN045**

**Limited Technical Inspection**

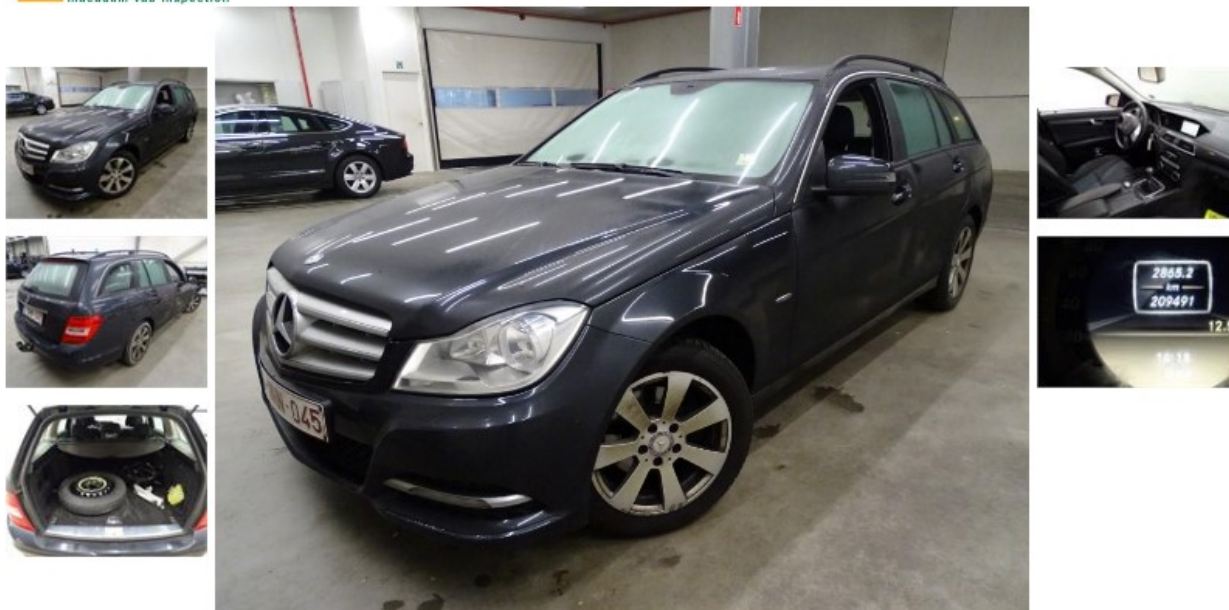
Vinnnumber:	<b>WDD2042011F921960</b>	Versionname:	<b>C BRE 200 CDI BlueEFF. S&amp;S 136PK</b>
First Registrationdate:	<b>21/05/2012</b>	Fiscalpower:	
Expertise Mileage:	<b>209491</b>	Power Kw:	<b>100</b>
Bodytype:	<b>Break</b>	Body color:	<b>Dark Grey</b>
Gearbox:	<b>MAN 6 VIT</b>	Paint type:	<b>Metalic</b>
Transmission:	<b>Back</b>	Rims summer:	<b>Aluminium</b>
Fueltype:	<b>Diesel</b>	Oil level:	<b>OK</b>
Battery functioning:	<b>Yes</b>	Parking lot:	<b>2310</b>
Number of doors:	<b>5</b>		
Number of seats:	<b>5</b>		
Number head rests:	<b>5</b>		
Rims summer:	<b>Aluminium</b>		
Category:	<b>Passenger Car</b>		
Oil level:	<b>OK</b>

Airco functioning	<b>OK</b>	Battery functioning	<b>Yes</b>
Tires wear profile	<b>OK</b>	Power steering	<b>Yes</b>
Idle position	<b>OK</b>	Sound engine	<b>OK</b>
Engine startingtime	<b>OK</b>	Clutch test	<b>OK</b>
Exhaust gass	<b>OK</b>	Wiper fluid level	<b>OK</b>
Handbrake	<b>OK</b>	Transmission	<b>OK</b>
		Lighting	<b>OK</b>
		Wiperblades	<b>OK</b>

205/55/16/91 H LightMetal				
Winter tyres:	Fr.L.	<b>Kleber: 3 mm</b>	Fr.R.	<b>Kleber: 3 mm</b>
	Re.L.	<b>Kleber: 5 mm</b>	Re.R.	<b>Kleber: 5 mm</b>
