BMW 3: 1HKL219

Limited Technical Inspection

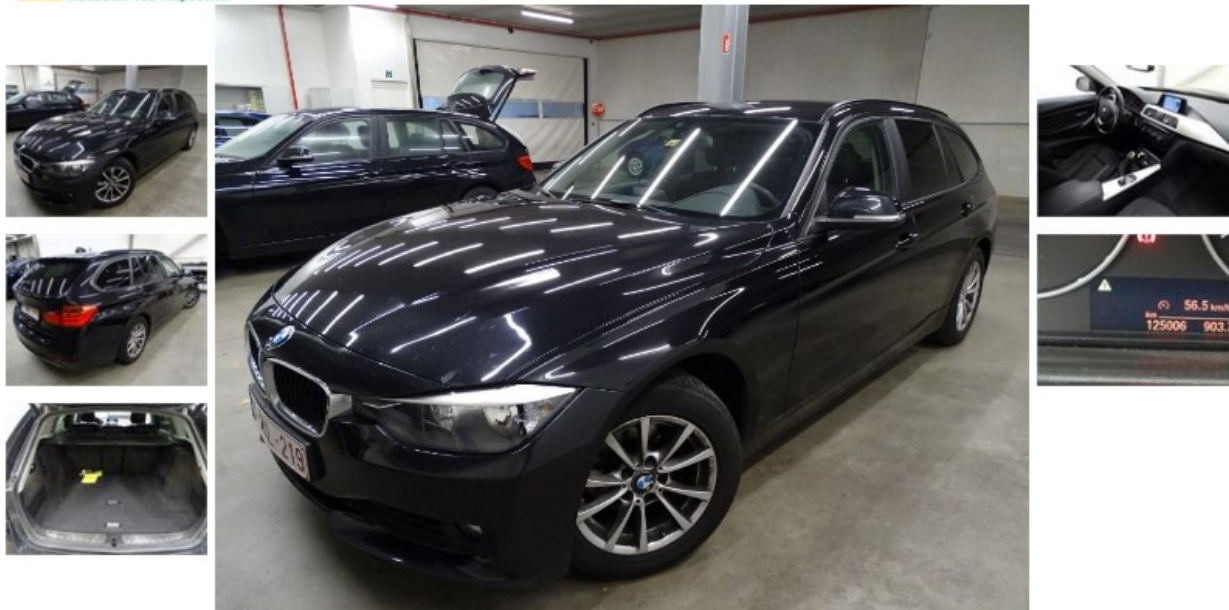
Total cost ex VAT	422,20
Door R R, Scratch(es), Acceptable	0,00
<i>No pictures to display</i>	
Door R L, Scratch(es), Acceptable	0,00
<i>No pictures to display</i>	
Wing R L, Scratch(es), LI - Repair and paint (complete)	308,20
