PEUGEOT 2008; 1HHU076

Limited Technical Inspection

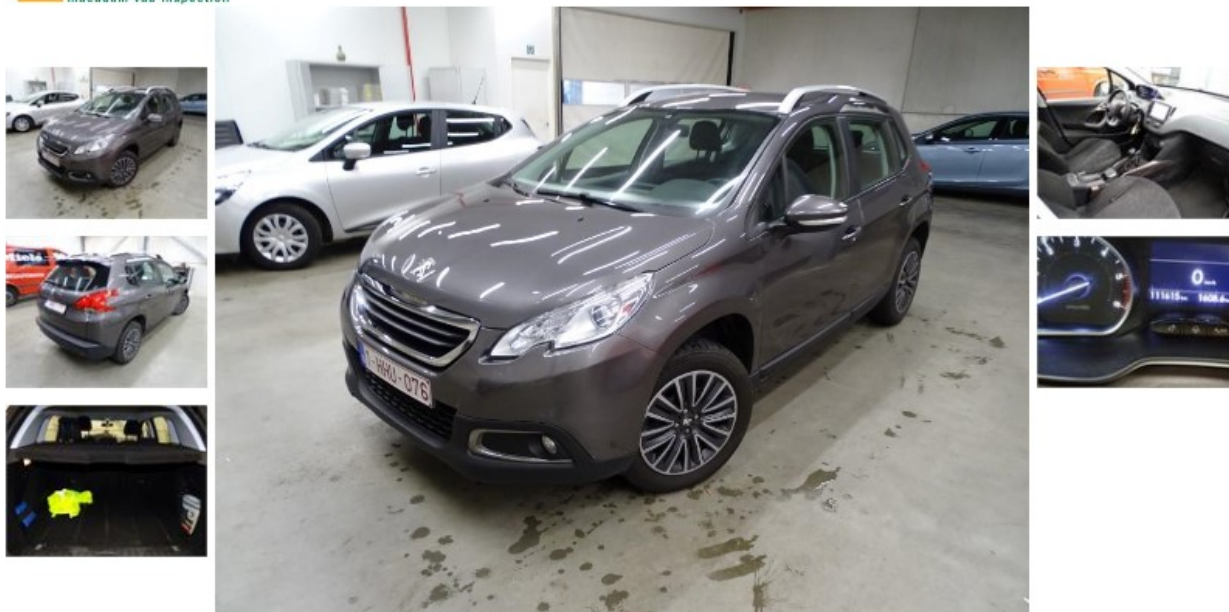
Vinnumber:	VF3CU8HR0EY006447	Versionname:	2008 Active 68PK
First Registrationdate:	28/07/2014	Fiscalpower:	
Expertise Mileage:	111615	Power Kw:	50
Bodytype:	Break	Body color:	Grey
Gearbox:	MAN 5 VIT	Paint type:	Metalic
Transmission:	Front	Rims summer:	Steel
Fueltype:	Diesel	Oil level:	OK
Maintenance:	OK	Parking lot:	2208
Battery functioning:	Yes		
Number of doors:	5		
Number of seats:	5		
Number head rests:	5		
Rims summer:	Steel		
Category:	Passenger Car		
Oil level:	OK		
Registration Certificate Car (BE):	Yes

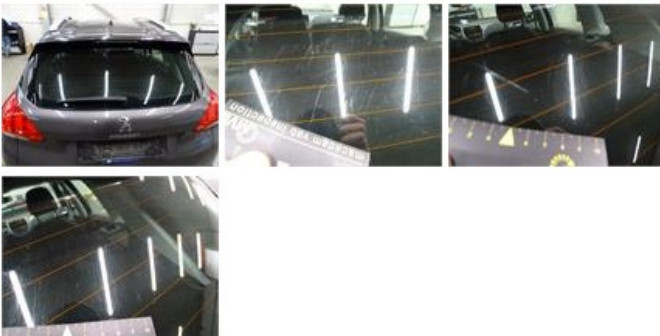
Rear window, Scratch(es), E - Replace 370,00
