PEUGEOT 2008; 1HHU102

Limited Technical Inspection

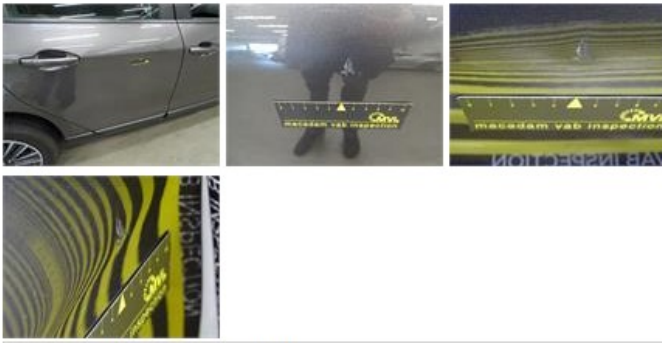
Emergency spare wheel	Yes	Jack	Yes
Total cost ex VAT			591,35
Bumper R, Scratch(es), Acceptable			0,00
<i>No pictures to display</i>			
Tailgate, Scratch(es), Acceptable			0,00
<i>No pictures to display</i>			
Bonnet, Stone chip(s), Acceptable			0,00
<i>No pictures to display</i>			
Door R R, Dent(s) and scratch(es), LI - Repair and paint (complete)			318,35
