FORD S Max: 1HZU609

Limited Technical Inspection

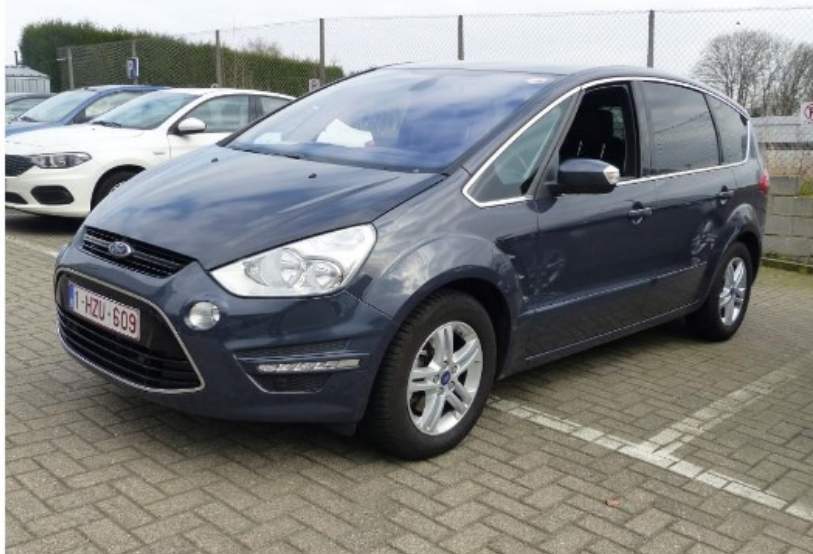
Vinnumber:	WF05XXGBWSEB01262	Versionname:	S-MAX Titanium Style St/St DPF 115PK
First Registrationdate:	12/11/2014	Fiscalpower:	
Expertise Mileage:	60141	Power Kw:	85
Bodytype:		Body color:	Grey
Gearbox:	MAN 6 VIT	Paint type:	Metallic
Transmission:	Front	Rims summer:	Aluminium
Fueltype:	Diesel	Oil level:	OK
Maintenance:	OK	Parking lot:	2323
Maintenance:	GEEN MELDING		
Battery functioning:	Yes		
Number of doors:	5		
Number of seats:	7		
Number head rests:	7		
Rims summer:	Aluminium		
Category:	Passenger Car		
Oil level:	OK		
Registration Certificate Car (BE):	Yes
