BMW 5: 1GKI142

Limited Technical Inspection

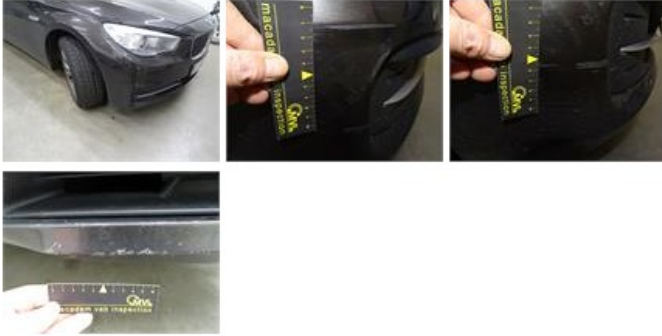
Alloy rim R R, Scratch(es), Acceptable	0,00
<i>No pictures to display</i>	
Door R R, Scratch(es), Acceptable	0,00
<i>No pictures to display</i>	
Tailgate, Scratch(es), Acceptable	0,00
<i>No pictures to display</i>	
Ignition key, Missing, E - Replace	0,00
<i>No pictures to display</i>	
Bumper F, Scratch(es), LI - Repair and paint (complete)	254,16
