BMW 3: 1JFD761

Limited Technical Inspection

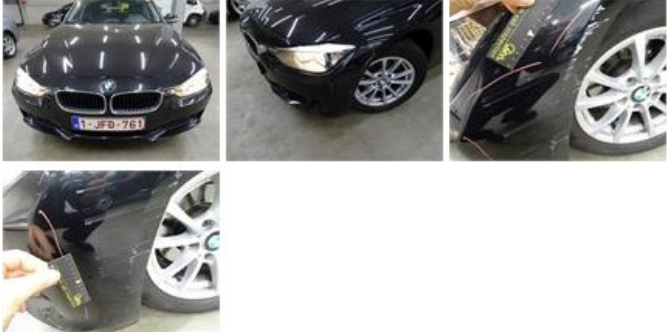
Alloy rim F L, Scratch(es), Acceptable	0,00
<i>No pictures to display</i>	
Tailgate, Scratch(es), Acceptable	0,00
<i>No pictures to display</i>	
Bumper F, Scratch(es), LI - Repair and paint (complete)	211,80
