BMW 1: 1GRA120

Limited Technical Inspection

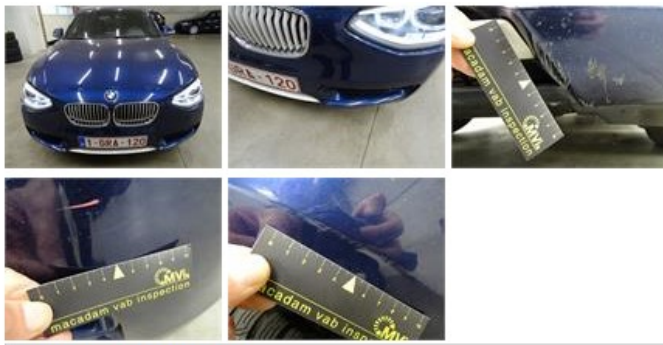
Repair kit	Yes	Compressor	Yes
Total cost ex VAT			274,80
Bumper F, Scratch(es), LI - Repair and paint (complete)			211,80
