**MERCEDES C BREAK: 1KEN193**

**Limited Technical Inspection**

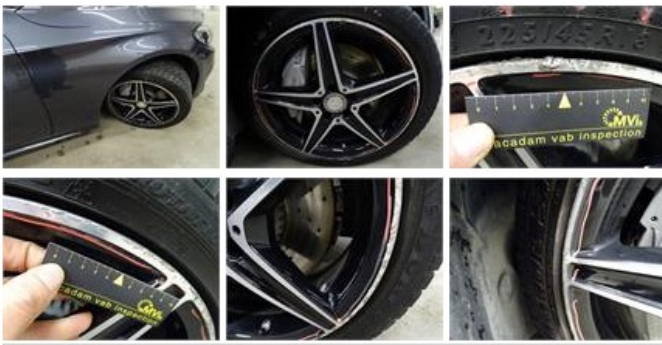
Total cost ex VAT	861,50
Door R R, Scratch(es), Acceptable	0,00
<i>No pictures to display</i>	
Bonnet, Stone chip(s), Acceptable	0,00
<i>No pictures to display</i>	
Alloy rim F R polished, Scratch(es), LI - Repair and paint (complete)	95,00
