**BMW 3: 1HNU870**

**Limited Technical Inspection**

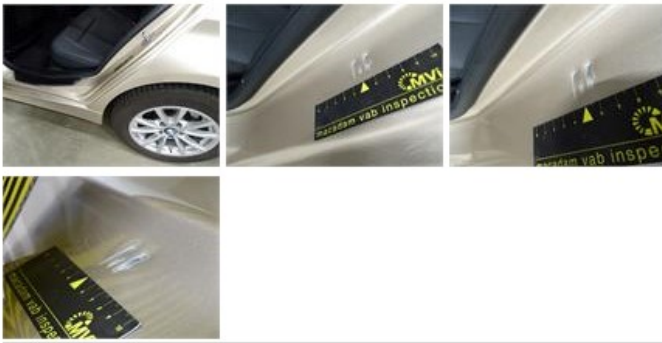
<b>Total cost ex VAT</b>	<b>115,56</b>
<b>Alloy rim R R, Scratch(es), Acceptable</b>	<b>0,00</b>
<i>No pictures to display</i>	
<b>Rocker panel inner R L, Dent(s), LI - Repair and paint (complete)</b>	<b>115,56</b>

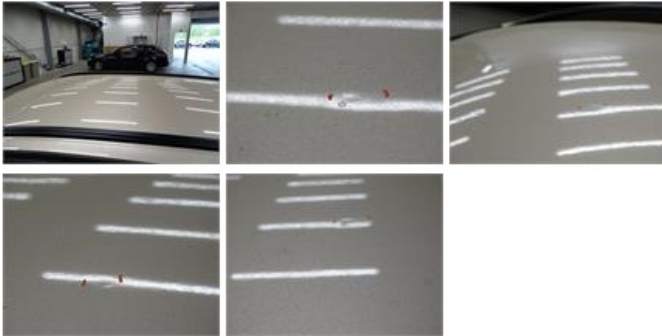
Rearview mirror housing R, Scratch(es), Acceptable	0,00
<i>No pictures to display</i>	
Bumper F, Dent(s), Acceptable	0,00
<i>No pictures to display</i>	
Roof, Hail damage, LI - Repair and paint (complete)	0,00
