MERCEDES GLA 180: 1KBD930

Limited Technical Inspection

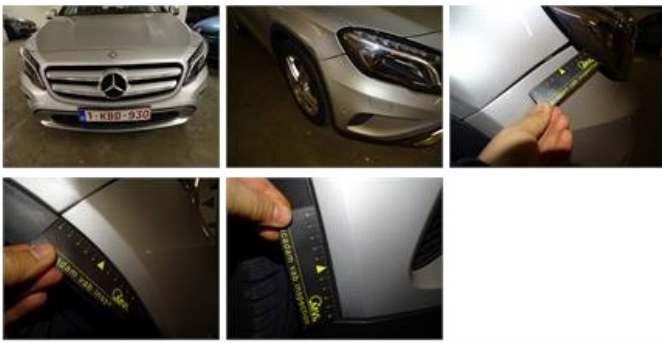
Bumper F, Dent(s) and scratch(es), It - Spot repair	115,56
-----------------------------------------------------	---------------

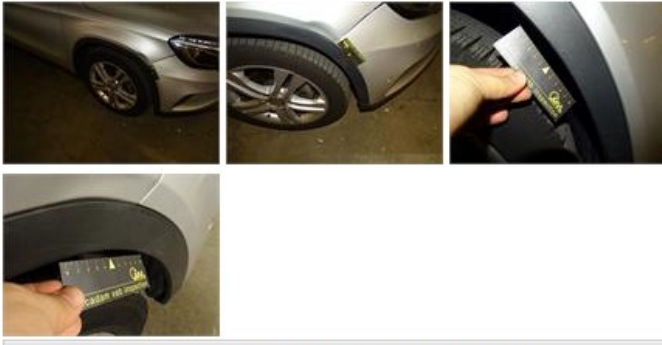
Wing moulding F R, Scratch(es), E - Replace 17,28
