**OPEL Insignia: 1FJC028**

**Limited Technical Inspection**

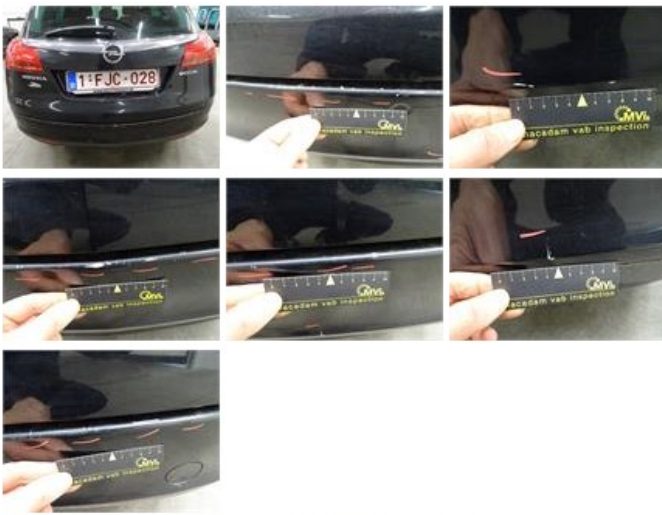
Spare wheel	<b>Yes</b>	Jack	<b>Yes</b>
Total cost ex VAT			<b>741,95</b>
Bumper R, Scratch(es), LI - Repair and paint (complete)			<b>211,80</b>

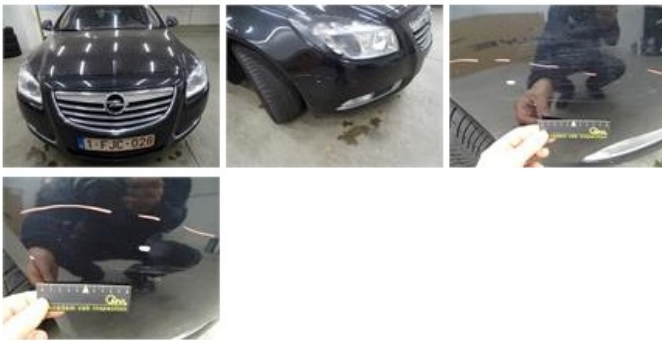
Bumper F, Scratch(es), LI - Repair and paint (complete)	211,80
---	--------
