BMW 3: 1HNF396

Limited Technical Inspection

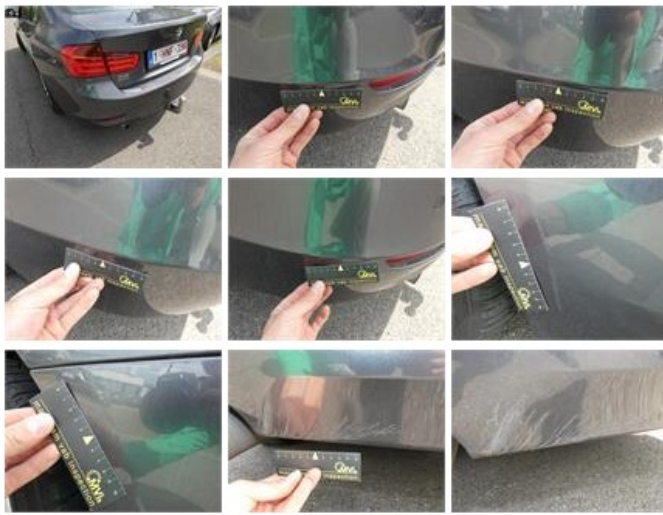
Bumper R, Dent(s) and scratch(es), LI - Repair and paint (complete)	259,80
---	---------------

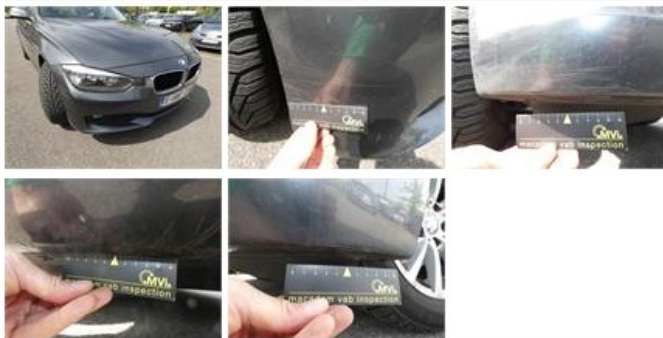
Wing R R, Scratch(es), Acceptable	0,00
<i>No pictures to display</i>	
Door R L, Scratch(es), Acceptable	0,00
<i>No pictures to display</i>	
Door R R, Scratch(es), Acceptable	0,00
<i>No pictures to display</i>	
Door F R, Scratch(es), Acceptable	0,00
<i>No pictures to display</i>	
Sill outer L, Scratch(es), Acceptable	0,00
<i>No pictures to display</i>	
Bonnet, Stone chip(s), Acceptable	0,00
<i>No pictures to display</i>	
Bumper F, Scratch(es), LI - Repair and paint (complete)	211,80
