VOLKSWAGEN Passat: 1GS153

Limited Technical Inspection

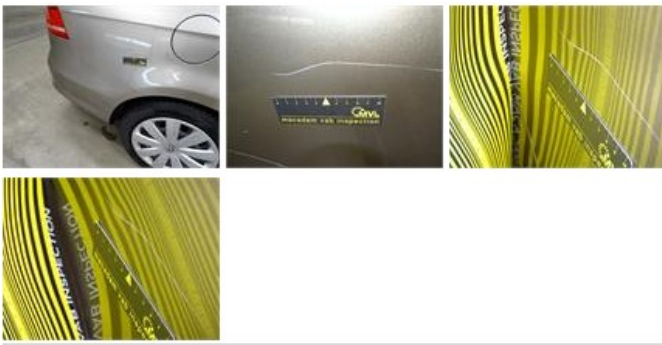
Total cost ex VAT	912,35
Wing R L, Scratch(es), Acceptable	0,00
<i>No pictures to display</i>	
Wing R R, Dent(s) and scratch(es), LI - Repair and paint (complete)	308,20

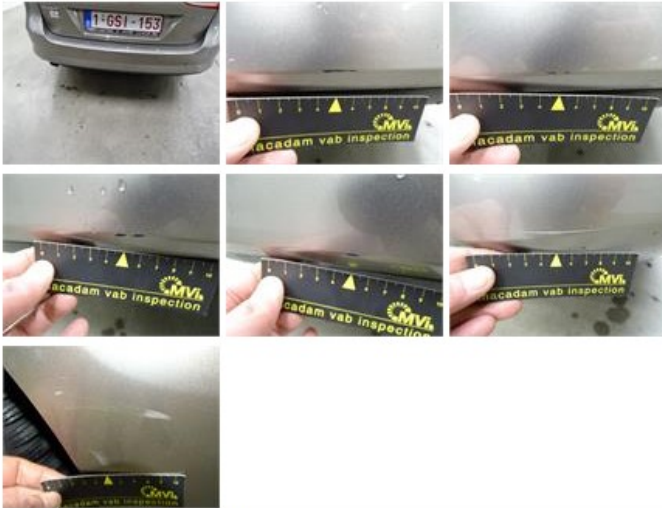
Bumper R, Scratch(es), LI - Repair and paint (complete) 211,80
