RENAULT Scenic: 1KFB424

Limited Technical Inspection

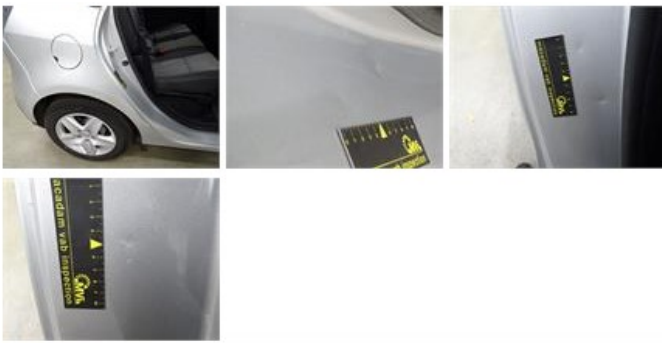
Total cost ex VAT	931,04
Wheel cover F R, Scratch(es), Acceptable	0,00
<i>No pictures to display</i>	
Rocker panel inner R R, Dent(s), LI - Repair and paint (complete)	115,56

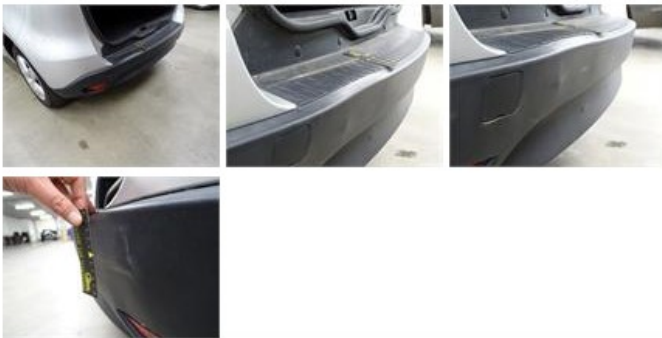
Bumper R, Dent(s), E - Replace 272,00
