OPEL Insignia: 1GWJ319

Limited Technical Inspection

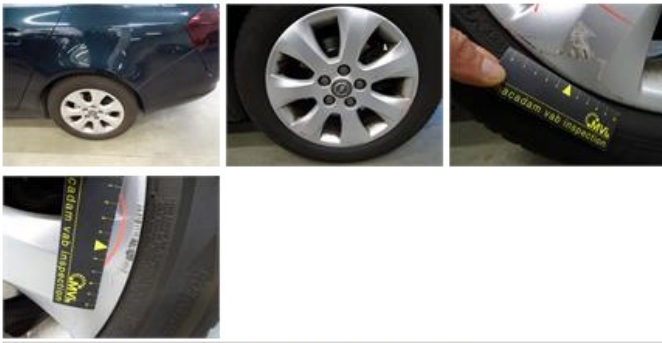
Repair kit	Yes	Compressor	Yes
Total cost ex VAT			691,88
Alloy rim R L, Scratch(es), LI - Repair and paint (complete)			95,00

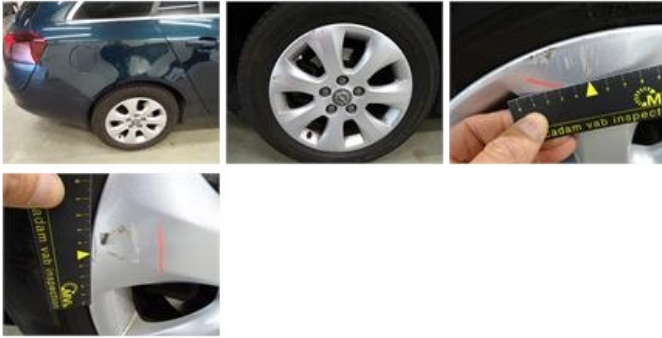
Alloy rim R R, Scratch(es), LI - Repair and paint (complete) 95,00
