PEUGEOT 508 SW: 1LNy609

Limited Technical Inspection

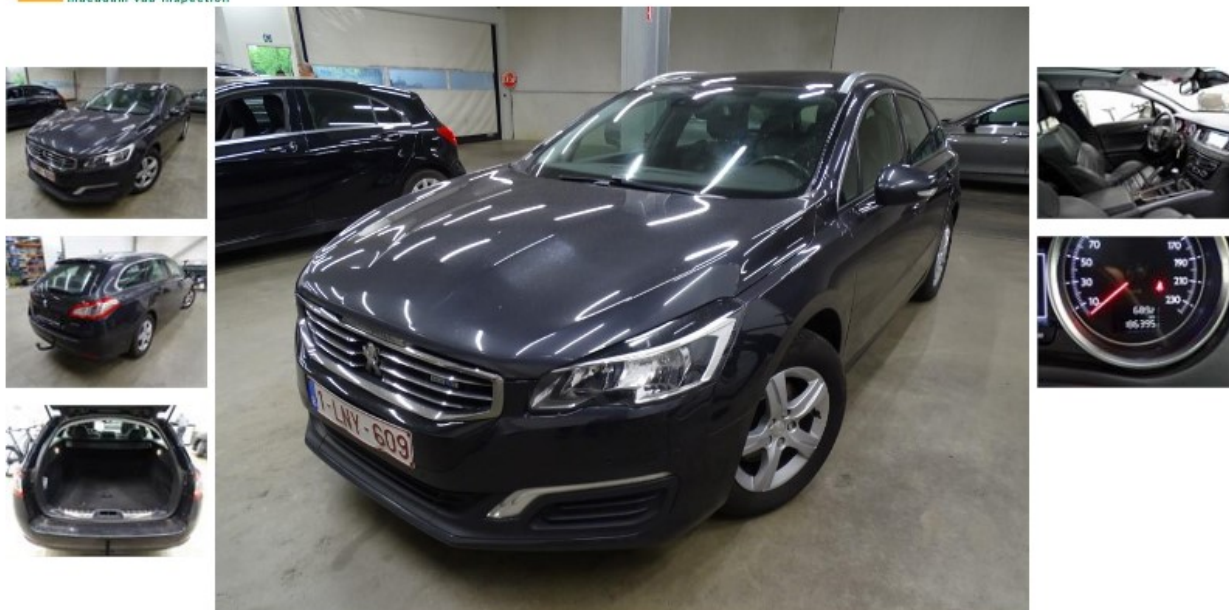
Vinnumber:	VF38EAHSMFL045062	Versionname:	2.0 BLUEHDI 100KW S/S ACTIVE
First Registrationdate:	2/11/2015	Fiscalpower:	
Expertise Mileage:	186395	Power Kw:	100
Bodytype:		Body color:	Grey
Gearbox:	MAN 6 VIT	Paint type:	Metalic
Transmission:	Front	Rims summer:	Aluminium
Fueltype:	Hybrid Diesel	Oil level:	OK
Battery functioning:	Yes	Parking lot:	4628
Number of doors:	5		
Number of seats:	5		
Number head rests:	5		
Rims summer:	Aluminium		
Category:	Passenger Car		
Oil level:	OK		
Registration Certificate Car (BE):	Yes
