MERCEDES B: 1GMQ956

Limited Technical Inspection

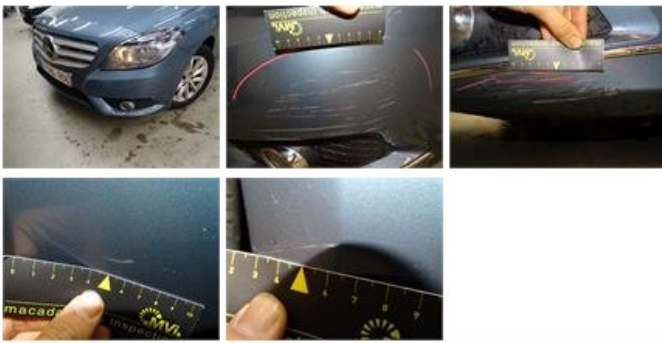
Total cost ex VAT	1181,50
Door F R, Scratch(es), Acceptable	0,00
<i>No pictures to display</i>	
Bumper F, Scratch(es), LI - Repair and paint (complete)	211,80

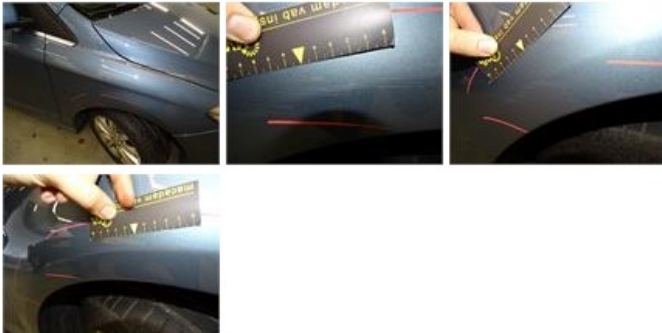
Rearview mirror housing L, Scratch(es), Acceptable	0,00
<i>No pictures to display</i>	
Wing F R, Scratch(es), 67 - Polish	0,00

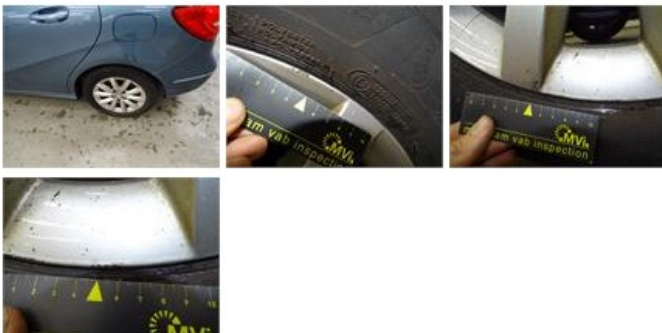
Bonnet, Chemical polution, Acceptable	0,00
<i>No pictures to display</i>	
Door R R, Scratch(es), Acceptable	0,00
<i>No pictures to display</i>	
Alloy rim R L, Scratch(es), LI - Repair and paint (complete)	95,00
