**TOYOTA YARIS: 1PRC038**

**Limited Technical Inspection**

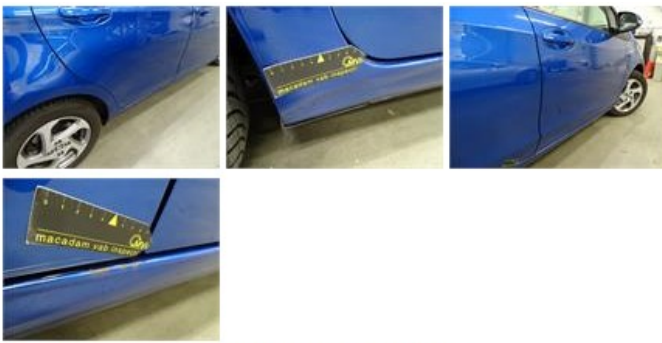
Emergency spare wheel	<b>Yes</b>	Jack	<b>Yes</b>
Total cost ex VAT			<b>1298,56</b>
Sill outer R, Dent(s) and scratch(es), LI - Repair and paint (complete)			<b>334,50</b>
