BMW 4 Gran Coupe: 1HHP527

Limited Technical Inspection

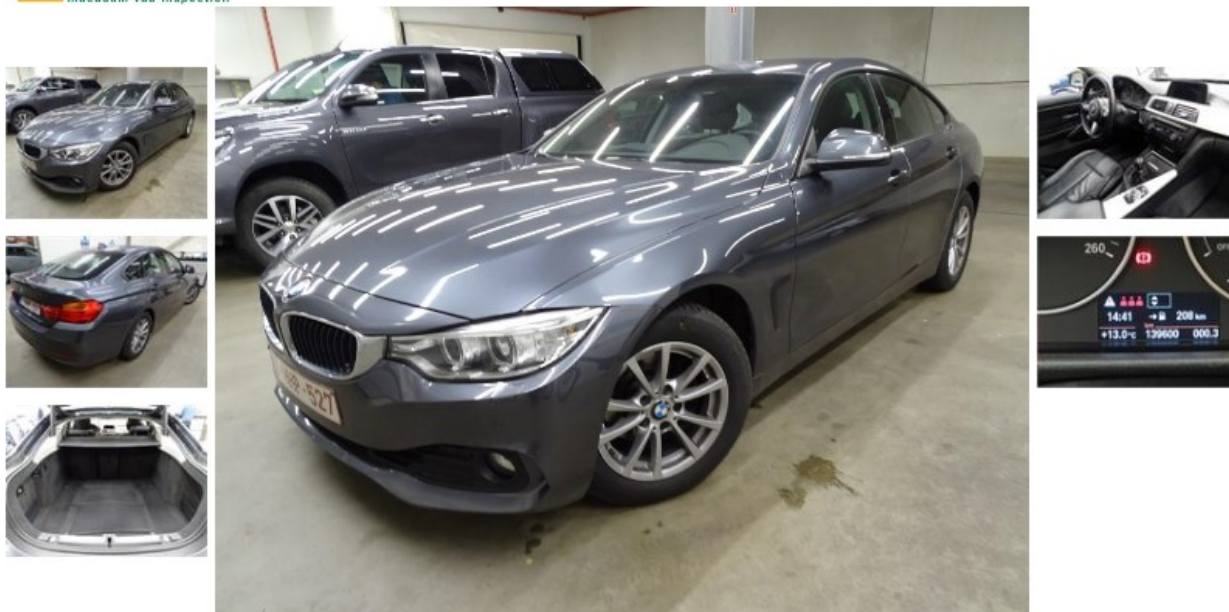
Vinnumber:	WBA4D51020D424156	Versionname:	4 GRAN COUPE 418d 136PK
First Registrationdate:	25/07/2014	Fiscalpower:	
Expertise Mileage:	139600	Power Kw:	100
Bodytype:		Body color:	Dark Grey
Gearbox:	MAN 6 VIT	Paint type:	Metalic
Transmission:	Back	Rims summer:	Aluminium
Fueltype:	Diesel	Oil level:	OK
Battery functioning:	Yes	Parking lot:	1109
Number of doors:	5		
Number of seats:	5		
Number head rests:	5		
Rims summer:	Aluminium		
Category:	Passenger Car		
Oil level:	OK		
Registration Certificate Car (BE):	Yes
