**VOLKSWAGEN PASSAT VARIANT: 1JVH746**

**Limited Technical Inspection**

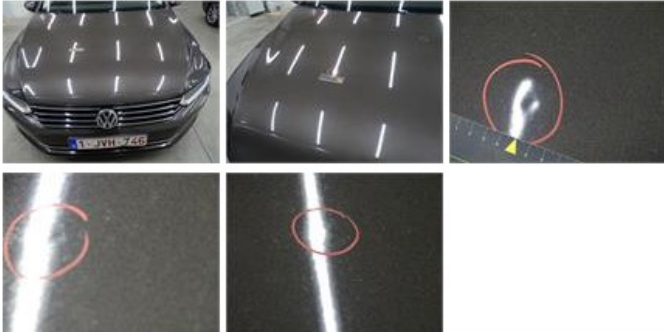
Bonnet, Dent(s), PDR - Paintless dent repair	102,60

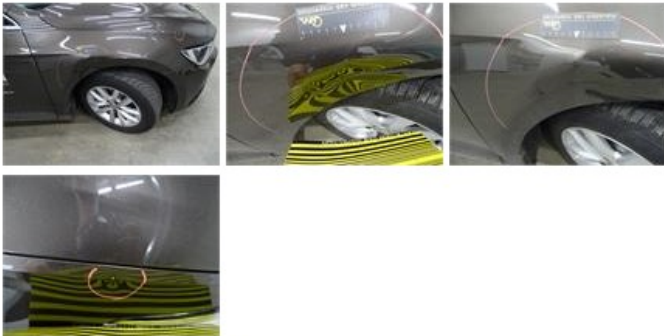
Roof, Dent(s), Acceptable	0,00
<i>No pictures to display</i>	
Alloy rim R R, Scratch(es), Acceptable	0,00
<i>No pictures to display</i>	
Wing F R, Dent(s) and scratch(es), LI - Repair and paint (complete)	220,18

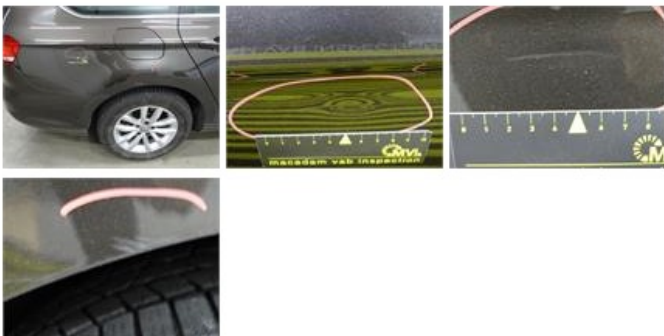
Door F R, Dent(s), Acceptable	0,00
<i>No pictures to display</i>	
Wing R R, Dent(s) and scratch(es), LI - Repair and paint (complete)	308,20
