BMW 2 ACTIVE TOURER: 1JVF573

Limited Technical Inspection

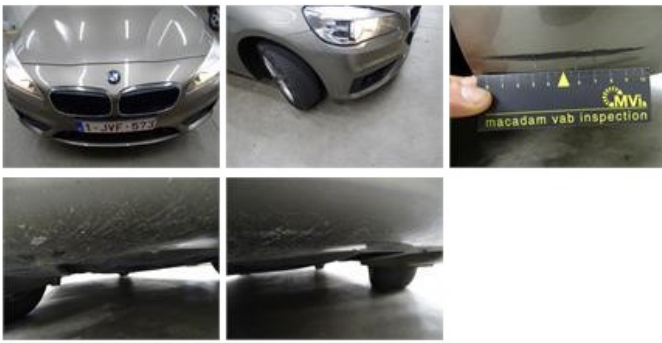
Total cost ex VAT	306,80
Door R R, Dent(s), Acceptable	0,00
<i>No pictures to display</i>	
Door R L, Scratch(es), Acceptable	0,00
<i>No pictures to display</i>	
Wing R L, Dent(s), Acceptable	0,00
<i>No pictures to display</i>	
Bumper F, Scratch(es), LI - Repair and paint (complete)	211,80

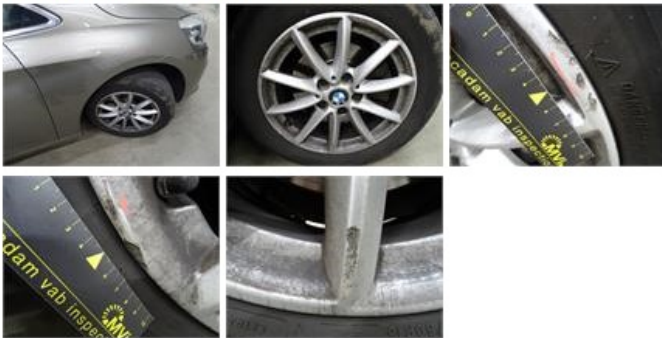
Alloy rim F R, Scratch(es), LI - Repair and paint (complete)	95,00
--------------------------------------------------------------	-------
