VOLVO XC60: 1KJX042

Limited Technical Inspection

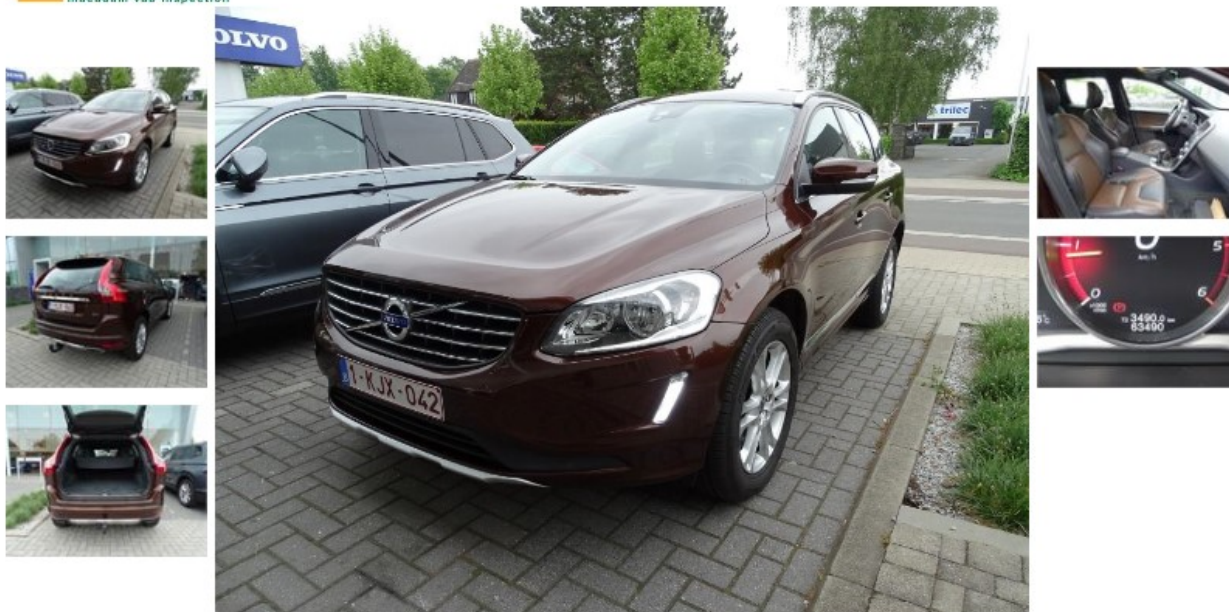
Vinnumber:	YV1DZ73C1F2758421	Versionname:	2.0 D4 2WD 133KW SUMMUM
First Registrationdate:	18/05/2015	Fiscalpower:	
Expertise Mileage:	63490	Power Kw:	133
Bodytype:		Body color:	Brown
Gearbox:	MAN 6 VIT	Paint type:	Metalic
Transmission:	Front	Rims summer:	Aluminium
Fueltype:	Diesel	Oil level:	OK
Maintenance:	OK	Parking lot:	2831
Maintenance:	IN 19657 KM		
Battery functioning:	Yes		
Number of doors:	5		
Number of seats:	5		
Number head rests:	5		
Rims summer:	Aluminium		
Category:	Passenger Car		
Oil level:	OK		
Registration Certificate Car (BE):	Yes

Airco functioning	OK	Battery functioning	Yes
Tires wear profile	OK	Power steering	Yes
Idle position	OK	Sound engine	OK
Engine startingtime	OK	Clutch test	OK
Exhaust gass	OK	Wiper fluid level	NOT OK
Handbrake	OK	Transmission	OK
		Lighting	OK
		Wiperblades	OK

235/60/18/103 V LightMetal				
Summer tyres:	Fr.L.	Pirelli: 7 mm	Fr.R.	Pirelli: 7 mm
	Re.L.	Pirelli: 6 mm	Re.R.	Pirelli: 6 mm
