VOLKSWAGEN GOLF VII: 1KFH010

Limited Technical Inspection

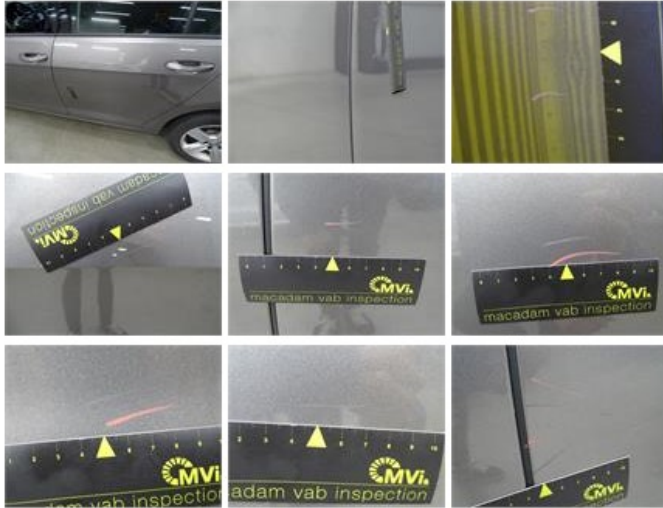
Wing F R, Scratch(es), Acceptable	0,00
<i>No pictures to display</i>	
Wing R L, Dent(s), Acceptable	0,00
<i>No pictures to display</i>	
Bumper R, Scratch(es), Acceptable	0,00
<i>No pictures to display</i>	
Door F L, Scratch(es), Acceptable	0,00
<i>No pictures to display</i>	
Door R L, Dent(s) and scratch(es), LI - Repair and paint (complete)	318,35

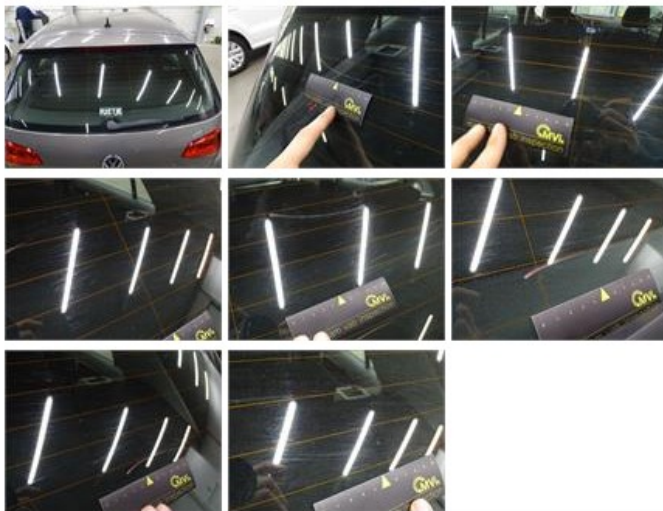
Bonnet, Chemical polution, Acceptable	0,00
<i>No pictures to display</i>	
Door F R, Dent(s), Acceptable	0,00
<i>No pictures to display</i>	
Rear window, Scratch(es), E - Replace	370,00

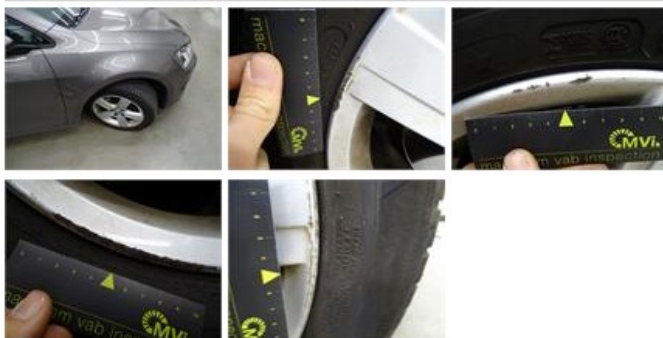
Alloy rim F R, Scratch(es), LI - Repair and paint (complete)	95,00
--	-------
