MERCEDES C: 1HNV580

Limited Technical Inspection

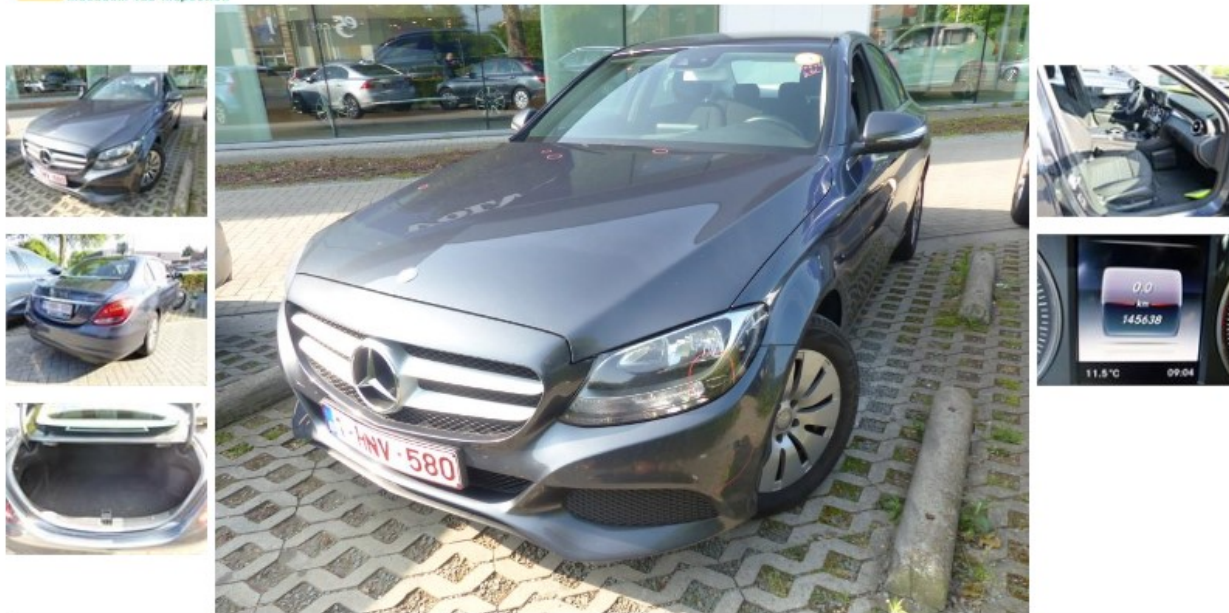
Vinnumber:	WDD2050041F070408	Versionname:	C BER 220 BlueTEC 163PK
First Registrationdate:	1/09/2014	Fiscalpower:	
Expertise Mileage:	145638	Power Kw:	120
Bodytype:		Body color	GRIS
Gearbox:	MAN 6 VIT	Body color	Dark Grey
Transmission:	Back	Paint type	Metalic
Fueltype:	Diesel	Rims summer	Aluminium
Maintenance	9400 KM	Oil level	OK
Maintenance	OK	Parking lot	3232
Battery functioning	Yes		
Number of doors	4		
Number of seats	5		
Number head rests	5		
Rims summer	Aluminium		
Category	Passenger Car		
Oil level	OK		
Registration Certificate Car (BE)	Yes
