**AUDI A4: 1HKG906**

**Limited Technical Inspection**

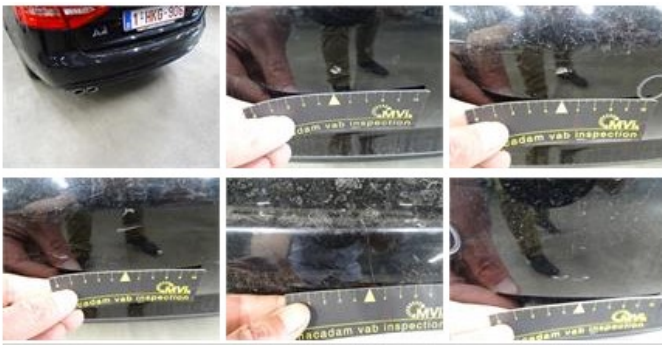
Total cost ex VAT	<b>947,39</b>
Door F R, Scratch(es), Acceptable	<b>0,00</b>
<i>No pictures to display</i>	
Bumper R, Scratch(es), LI - Repair and paint (complete)	<b>211,80</b>

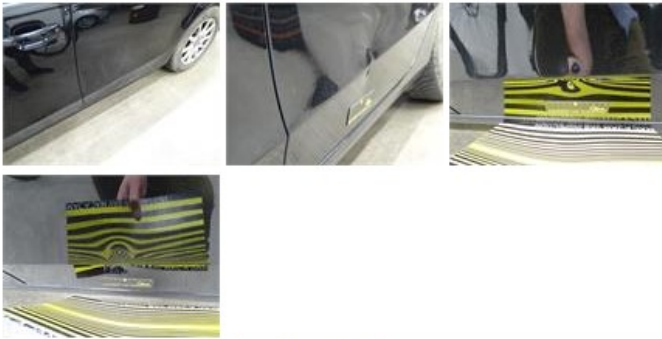
Door R L, Dent(s), LI - Repair and paint (complete) 318,35
