AUDI A3: 1GNE637

Limited Technical Inspection

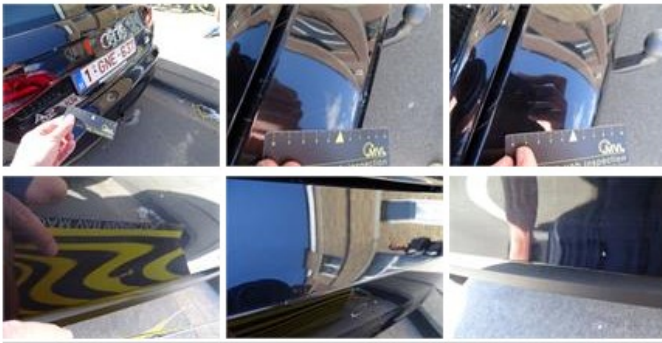
Repair kit	Yes	Compressor	Yes
Total cost ex VAT			401,80
Door R L, Dent(s), Acceptable			0,00
<i>No pictures to display</i>			
Bumper R, Dent(s) and scratch(es), LI - Repair and paint (complete)			211,80

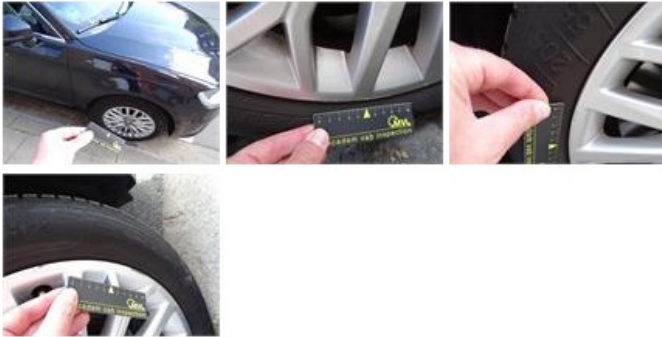
Alloy rim F R, Scratch(es), LI - Repair and paint (complete) 95,00
